Product Change Notification / SYST-28ZNPW394

ERRATA - PIC18(L)F24/25K40 Family Silicon Errata and Data Sheet Clarification Revision

PIC18(L)F24/25K40 Family Silicon Errata and Data Sheet Clarification

The PIC18(L)F24/25K40 devices that you have received conform functionally to the current device data sheet (DS40001843D), except for the anomalies described in this document.

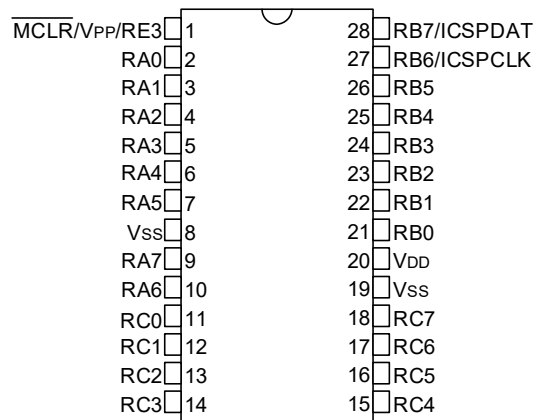
Figure 1. 28-pin SPDIP, SSOP, SOIC

The correct marking for pin 26 on the 28-pin SPDIP/SSOP/SOIC package is **RB5**.
