## Product Change Notification / SYST-11EHZX379

ERRATA - KSZ9896C Silicon Errata and Data Sheet Clarification

## KSZ9896C Silicon Errata and Data Sheet Clarification

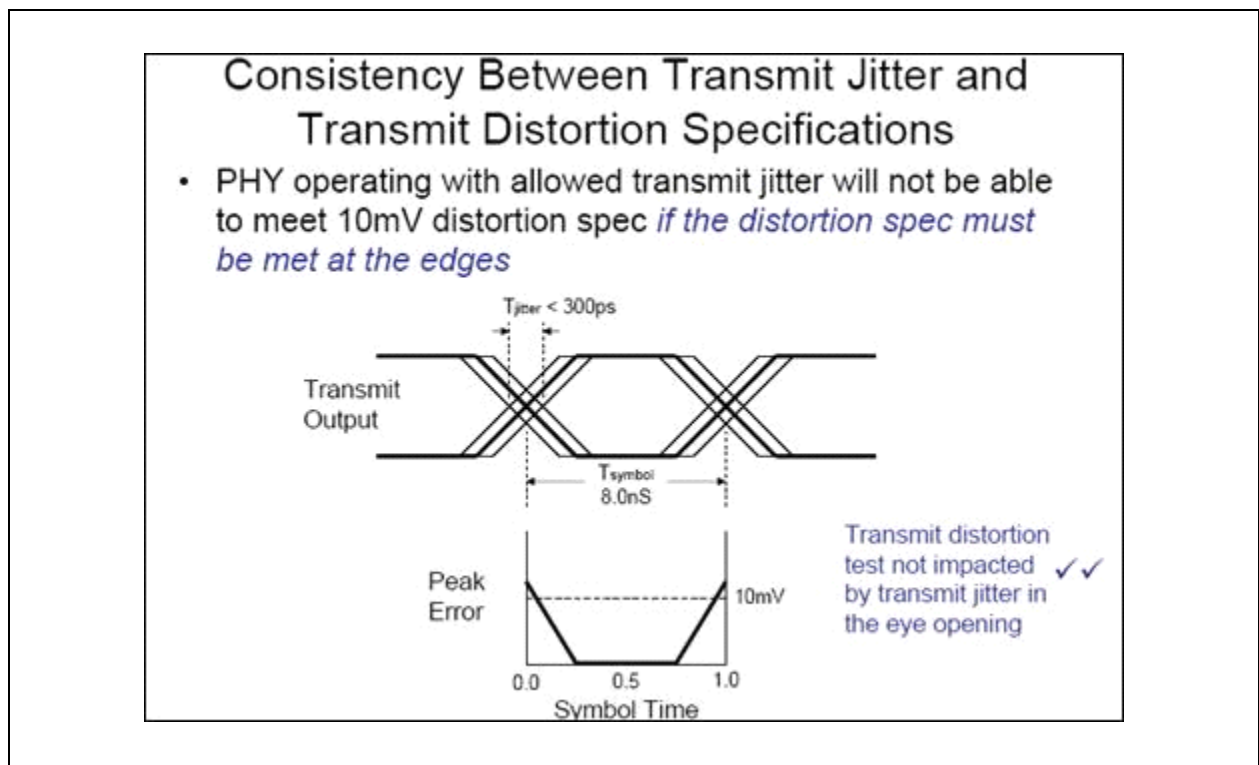
**FIGURE 1: IEEE DOCUMENT PAGE 6**

The device's 1000BASE-T Transmitter Distortion is approximately 40mV, versus the <10mV indicated in the IEEE specification.

IEEE testing calls for <10mV peak transmitter distortion for at least 60% of the UI within the eye opening. However, this measurement might not be valid, as the transmit distortion test is sensitive to transmit jitter. Refer to the explanation below, taken from the aforementioned IEEE document.

- On page 6, a contradiction between Transmit Jitter and Transmit Distortion requirements:

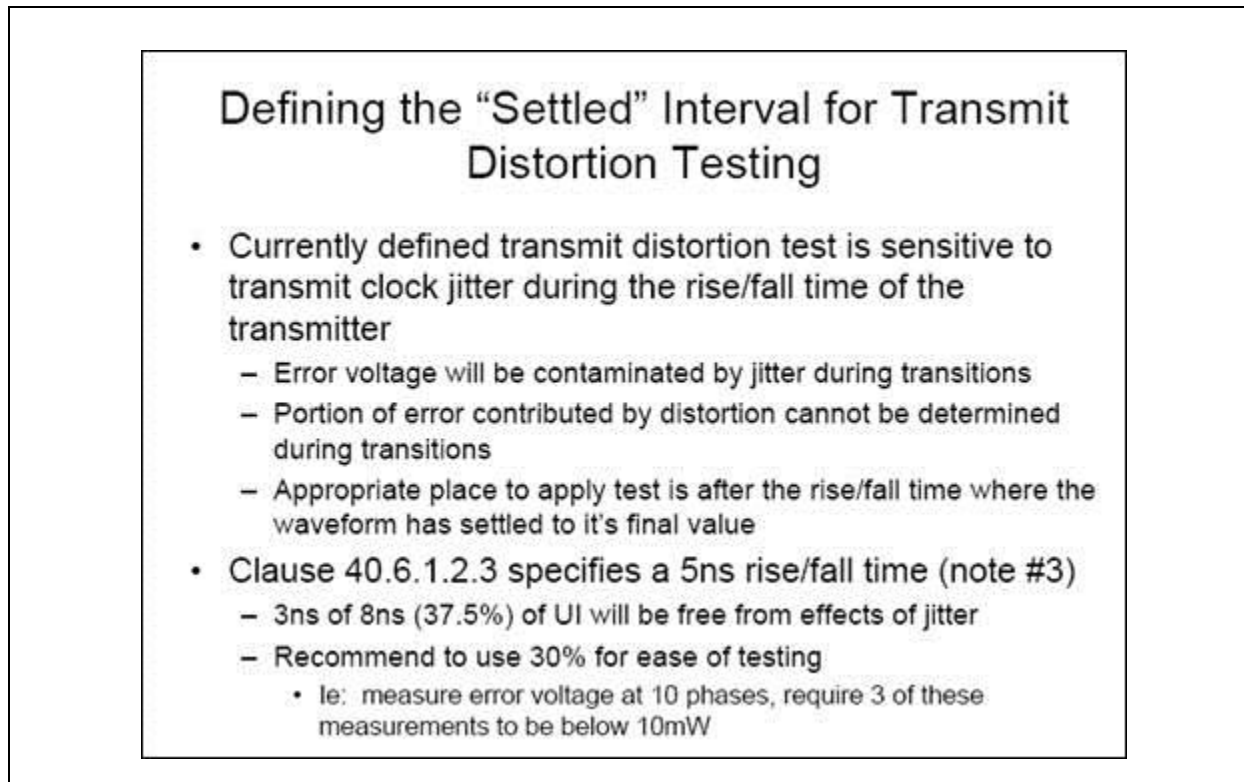
**FIGURE 2: IEEE DOCUMENT PAGE 7**

- On page 7:
  - The transmit distortion test is sensitive to transmit clock jitter during the rise/fall time.
  - It is recommended to change the requirement to use at least 30%, instead of at least 60%, of the UI within the eye opening for the <10mV peak transmitter distortion.
