Product Change Notification / SYST-05XJMF681

ERRATA - PIC18(L)F26/45/46K40 Family Silicon Errata and Data Sheet Clarification

PIC18(L)F26/45/46K40 Family Silicon Errata and Data Sheet Clarification

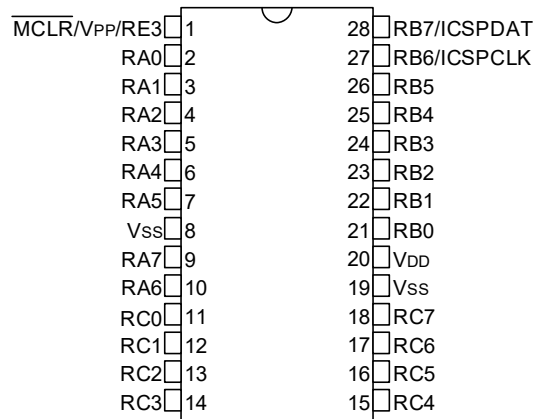
Figure 1. 28-pin SPDIP, SSOP, SOIC

The correct marking for pin 26 on the 28-pin SPDIP/SSOP/SOIC package is **RB5**.

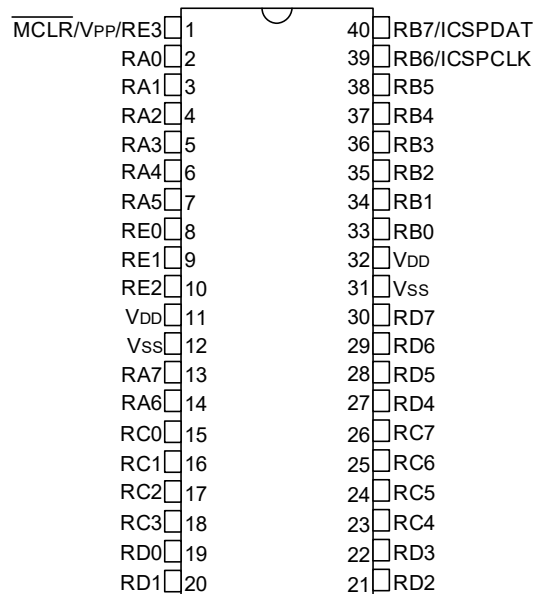
Figure 3. 40-pin PDIP

The correct marking for pin 38 on the 40-pin SPDIP package is **RB5**.

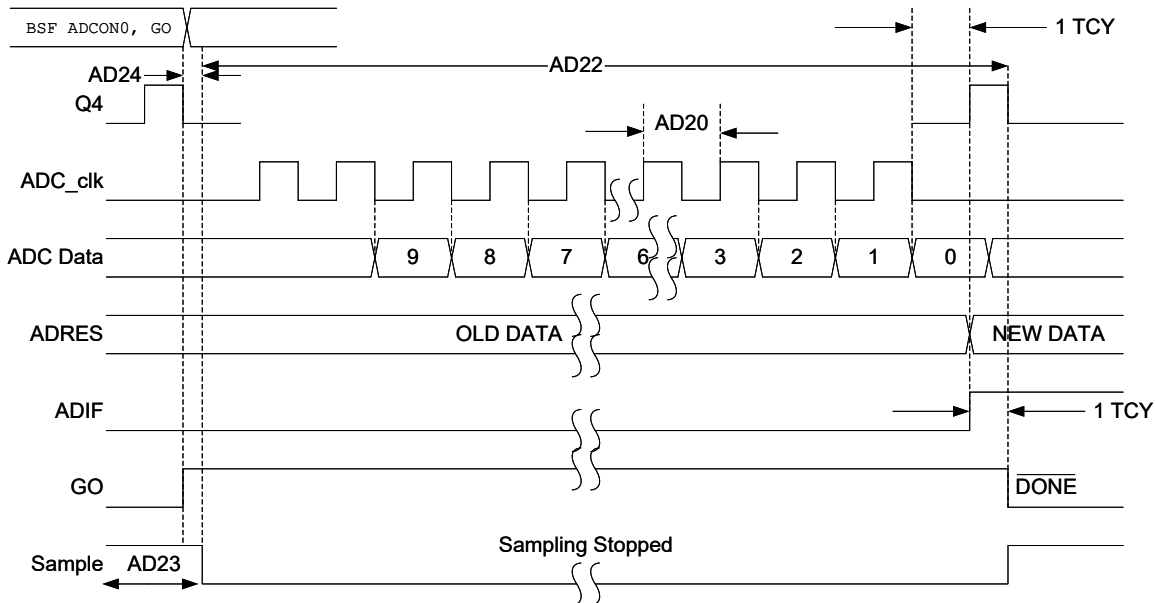
Figure 38-10: ADC Conversion Timing (ADC Clock F_{OSC} -Based)

Refer to the images below for corrections of Figure 38-10 and Figure 38-11. Previously, the parameter numbers were incorrect.
