Product Change Notification / SYST-28ROFM428

ERRATA - PIC18F26/46/56Q43 Silicon Errata and Data Sheet Clarifications Revision

PIC18F26/46/56Q43 Silicon Errata and Data Sheet Clarifications

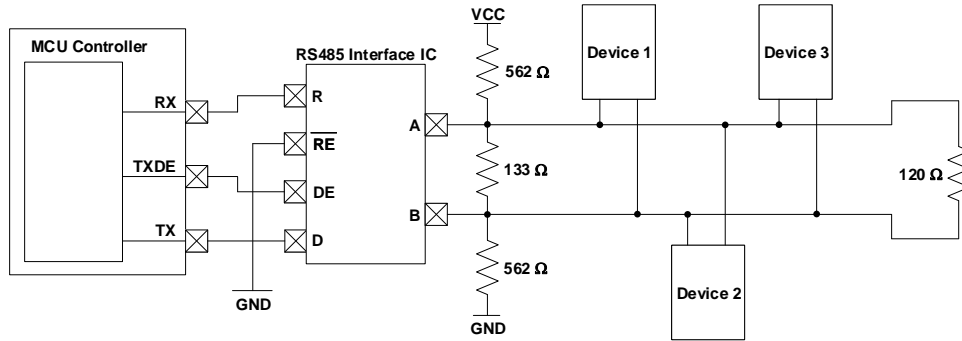
1.7.1 UART TXDE Signal May go Low Before The STOP Bit Has Been Entirely Transmitted.

The UART Transmit Drive Enable (TXDE) signal could potentially transition into a low state before the UART STOP bit has been entirely transmitted due to the effects of parasitic capacitance on the TX line. In some applications, this could result in communication being prematurely terminated due to the TXDE bit going low before the STOP bit has had enough time to settle.

In order to ensure that the STOP bit settles into its final logic state before the TXDE signal transitions low, a biasing circuit can be implemented. A biasing circuit allows the TX line to either be driven high or low, rather than being left in a floating tri-state mode where prolonged rise or fall times could lead to communication being disrupted. This bias circuit should only be implemented on one end of the serial bus, and a termination resistor should be used on the other end. The figure below show an example of a bias circuit that can be used to achieve this.

Please note that the resistor values used in this circuit are recommendations, and that the actual resistor values required may vary based on the application.
