## Product Change Notification / SYST-23CMIU808

ERRATA - dsPIC33CK256MP508 Family Silicon Errata and Data Sheet Clarification

## dsPIC33CK256MP508 Family Silicon Errata and Data Sheet Clarification

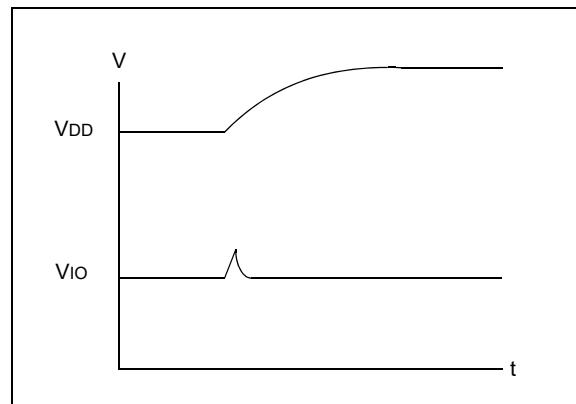
FIGURE 1-1: I/O RAMP

During a fast device power-up when the  $V_{DD}$  ramp is less than 4 mS, the I/O pins may drive up to 100  $\mu$ A current for a duration of up to 10  $\mu$ S (Figure 1-1).

1. Slow down the  $V_{DD}$  ramp time (greater than 4 mS for  $V_{DD}$  to ramp 0V to 3.3V).
2. Ensure the circuitry that is connected to the pins can endure this pulse.
