## Product Change Notification / SYST-30JOVN709

ERRATA - LAN8670/1/2 10BASE-T1S Ethernet PHY Transceiver Silicon Errata and Data Sheet Clarifications

## Silicon Errata and Data Sheet Clarifications

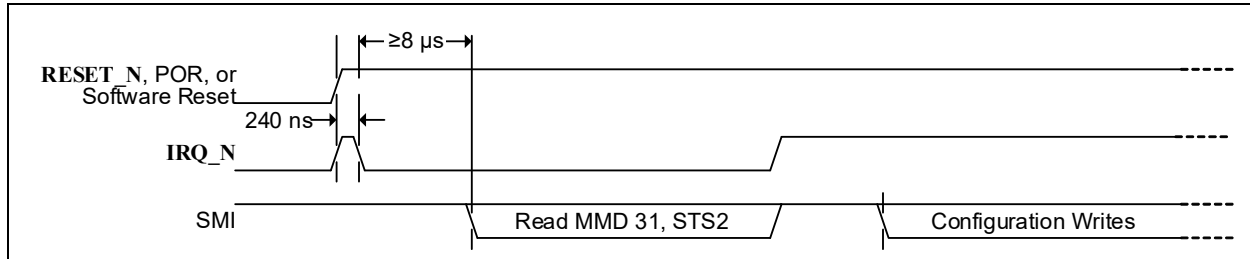
## s4. Module: Incorrect reset indication on IRQ\_N

The device does not properly assert the IRQ\_N pin to interrupt the station management entity once it has been reset. The device should allow the IRQ\_N pin to be pulled high when it is in reset and only assert IRQ\_N low once it is ready for initialization by the station management entity. However, the device will assert IRQ\_N low during reset. Once the device reset is deasserted, the IRQ\_N pin will become deasserted for about 240 ns. The station management entity can only attempt communication with the device 8  $\mu$ s following reset.

When the device has been reset, the station management entity cannot immediately communicate with the device.

The station management entity will receive a false interrupt indication on IRQ\_N when the device is reset. This may result in a failure to communicate with the device.

The station management entity must wait at least 8  $\mu$ s following reset to communicate with the device.

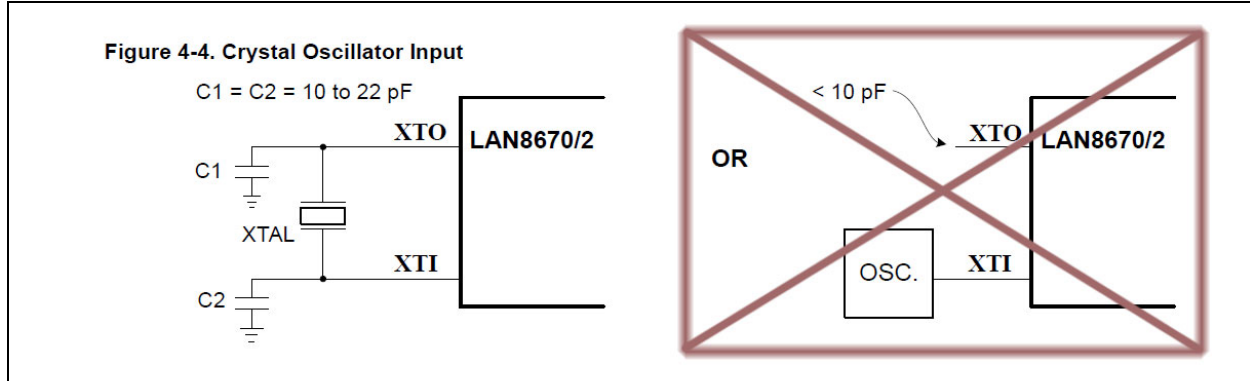
## d4. Module: Figure 4-4. Crystal Oscillator Input

Updates to drawing as shown below:
