Product Change Notification / SYST-14KFNM046

ERRATA - PIC16(L)F1782/1783 Family Silicon Errata and Data Sheet Clarification

PIC16(L)F1782/1783 Family Silicon Errata and Data Sheet Clarification

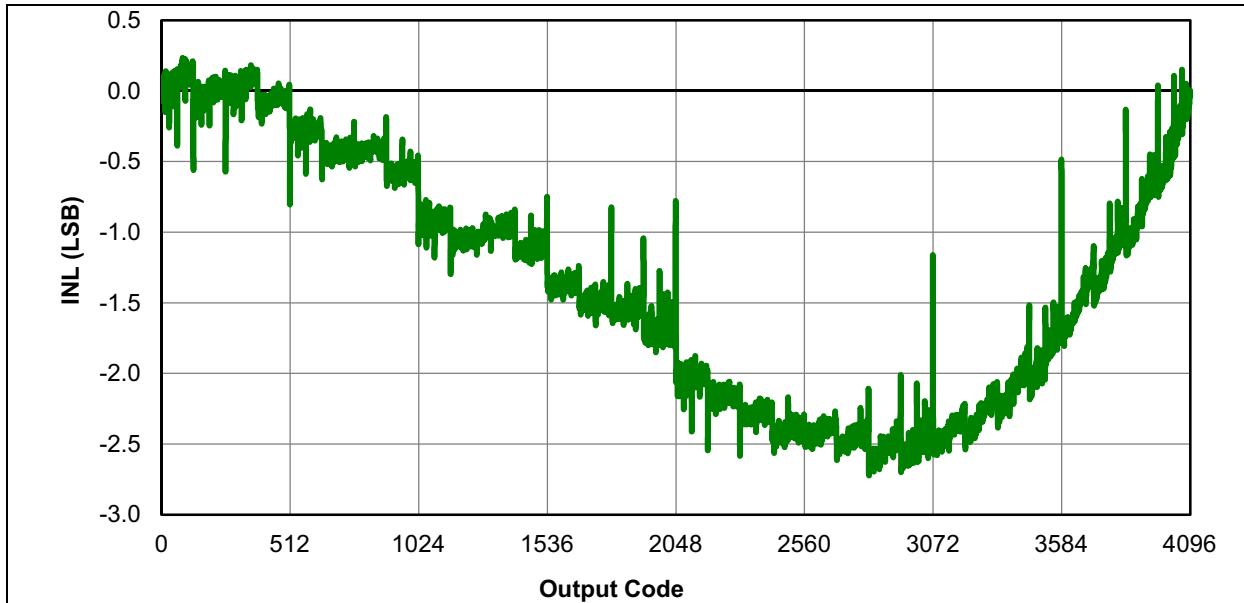
FIGURE 1: ADC 12-BIT MODE, SINGLE-ENDED INL, $V_{DD} = 3.0V$, $T_{AD} = 4 \mu s$, $25^{\circ}C$, TYPICAL MEASURED VALUES

The ADC linearity is ± 4 LSB for the 12-bit mode. Below are typical INL graphs in 12-bit mode (See [Figure 1](#) and [Figure 2](#)).

None.

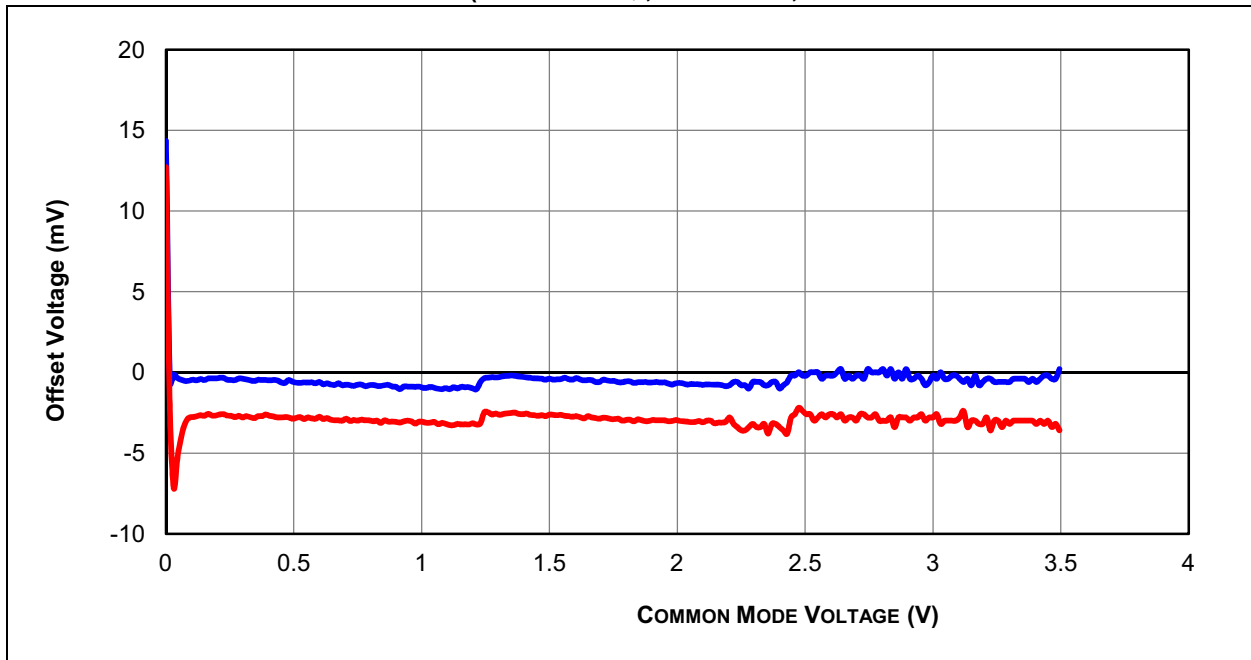
FIGURE 3: OP AMP TYPICAL OFFSET VOLTAGE AT 25°C, HIGH GBWP MODE (OPAxSP = 1), VDD = 3.6V, 0V ≤ CMV ≤ 5.5V

The op amp offset at Common mode input voltages below 200 mV increases with respect to temperature. Below are typical graphs showing the increase in offset (See [Figure 3](#), [Figure 4](#) and [Figure 5](#)).

None.

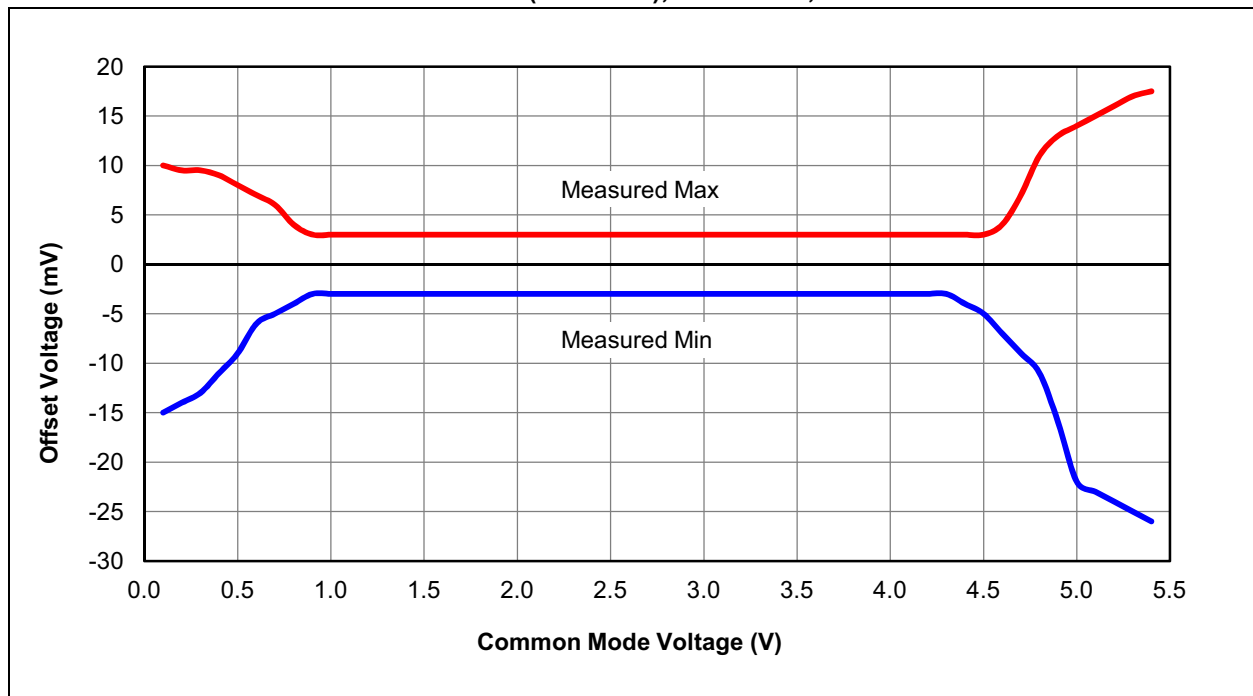
FIGURE 6: COMPARATOR INPUT OFFSET, TYPICAL MEASURED VALUES, NORMAL SPEED MODE ($CxSP = 1$), $V_{DD} = 5.5V$, PIC16F1782/1783 ONLY

CMRR performance for the range of $V_{SS} + 1V$ to $V_{DD} - 1V$ is better than specified in the data sheet.

See [Figure 6](#) and [Figure 7](#).
