Product Change Notification / SYST-28DSPA532

ERRATA - PIC18F27/47/57Q43 Silicon Errata and Data Sheet Clarifications

PIC18F27/47/57Q43 Silicon Errata and Data Sheet Clarifications

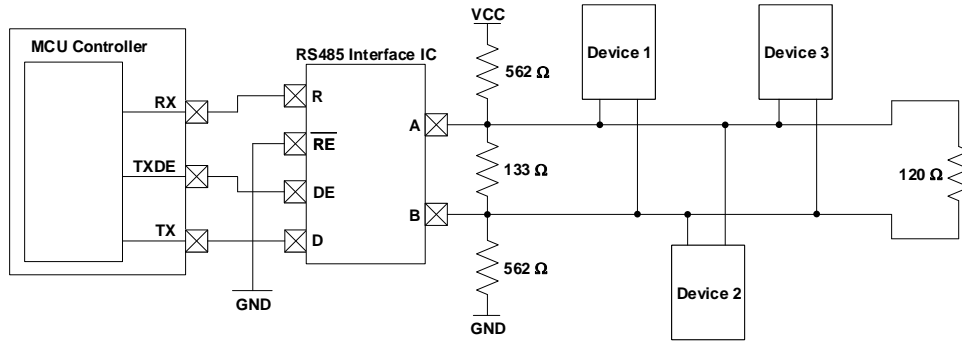
1.7 Module: Universal Asynchronous Receiver Transmitter (UART)**1.7.1 UART TXDE Signal May go Low Before The STOP Bit Has Been Entirely Transmitted.**

The UART Transmit Drive Enable (TXDE) signal could potentially transition into a low state before the UART STOP bit has been entirely transmitted due to the effects of parasitic capacitance on the TX line. In some applications, this could result in communication being prematurely terminated due to the TXDE bit going low before the STOP bit has had enough time to settle.

In order to ensure that the STOP bit settles into its final logic state before the TXDE signal transitions low, a biasing circuit can be implemented. A biasing circuit allows the TX line to either be driven high or low, rather than being left in a floating tri-state mode where prolonged rise or fall times could lead to communication being disrupted. This bias circuit should only be implemented on one end of the serial bus, and a termination resistor should be used on the other end. The figure below show an example of a bias circuit that can be used to achieve this.

Please note that the resistor values used in this circuit are recommendations, and that the actual resistor values required may vary based on the application.
