Product Change Notification / SYST-15WGPU924

ERRATA - PIC18F25/45/55Q43 Silicon Errata and Data Sheet Clarifications

PIC18F25/45/55Q43 Silicon Errata and Data Sheet Clarifications

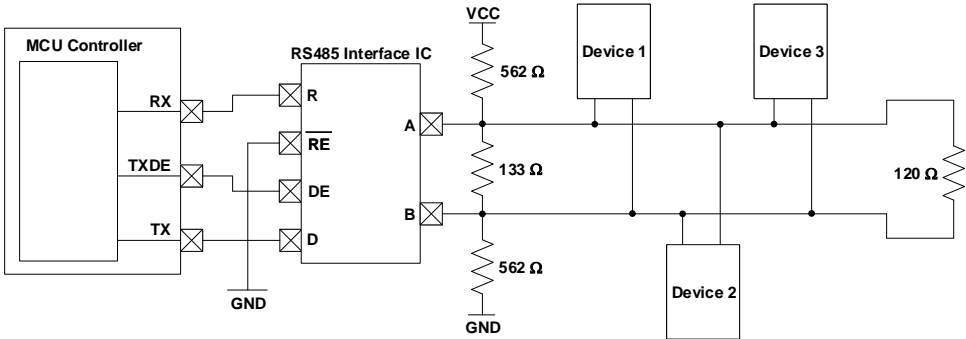
1.7.1 UART TXDE Signal May Go Low Before the STOP Bit Has Been Entirely Transmitted

The UART Transmit Drive Enable (TXDE) signal could potentially transition into a low state before the UART STOP bit has been entirely transmitted due to the effects of parasitic capacitance on the TX line. In some applications, this could result in communication being prematurely terminated due to the TXDE bit going low before the STOP bit has had enough time to settle.

To ensure that the STOP bit settles into its final logic state before the TXDE signal transitions low, a biasing circuit can be implemented. A biasing circuit allows the TX line to either be driven high or low, rather than being left in a floating tri-state mode where prolonged rise or fall times could lead to communication being disrupted. This bias circuit should only be implemented on one end of the serial bus, and a termination resistor should be used on the other end. The figure below shows an example of a bias circuit that can be used to achieve this.

Please note that the resistor values used in this circuit are recommendations, and that the actual resistor values required may vary based on the application.
