Product Change Notification / SYST-24YPYI186

dsPIC33EDV64MC205 Family Silicon Errata and Data Sheet Clarification

Added silicon issue 30 (MOSFET Gate Driver).

dsPIC33EDV64MC205 Silicon Errata and Data Sheet Clarification

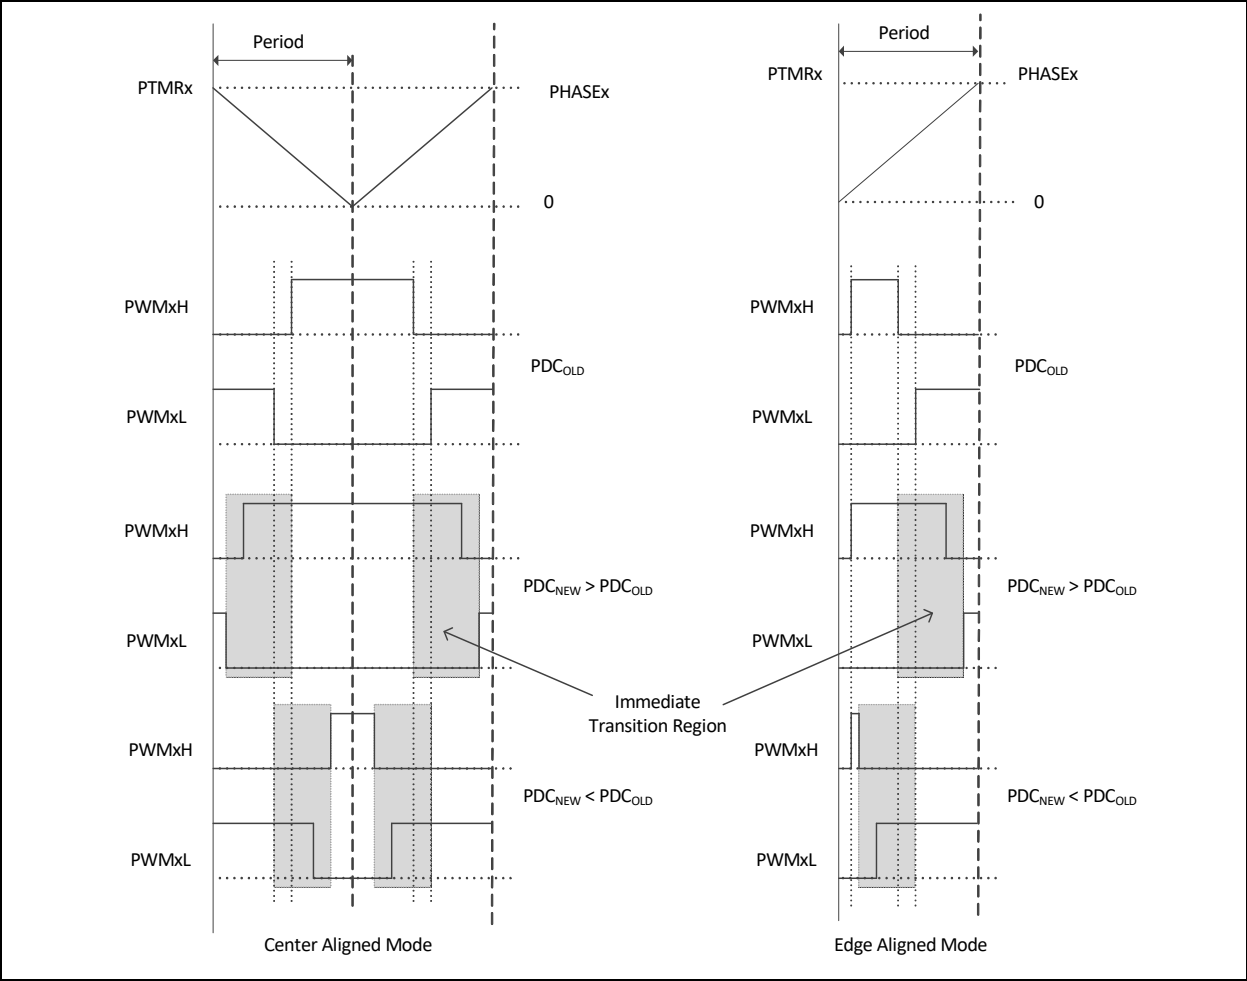
FIGURE 1: TIMING DIAGRAMS FOR CENTER-ALIGNED AND EDGE-ALIGNED MODES

The PWM generator may not assert dead time on the edges of transitions. This has been observed when all of the following conditions are present:

- The PWM generator is configured to operate in Complementary mode with Independent Time Base (ITB) or master time base;
- Immediate update is enabled; and
- The value in the PDCx register is updated in such a manner that the PWMxH and PWMxL outputs make an immediate transition.

The current duty cycle, PDCOLD, newly calculated duty cycle, PDCNEW and the point at which a write to the Duty Cycle register occurs within the PWM

time base will determine if the PWMxH and PWMxL outputs make an immediate transition. PWMxH and PWMxL outputs make an immediate transition if the Duty Cycle register is written with a new value, PDCNEW, at a point of time when the PWM time base is counting a value that is in between PDCNEW and PDCOLD. Additionally, writing to the Duty Cycle register, close to the instant of time where dead time is being applied, may result in a reduced dead time effective on the PWMxH and PWMxL transition edges.

In Figure 1, if the duty cycle write occurred in the shaded box, then PWMxH and PWMxL will make an immediate transition without dead time.

None.

However, in most applications the duty cycle update timing can be controlled using the TRIGx trigger, or Special Event Trigger, such that the above mentioned conditions are avoided altogether.

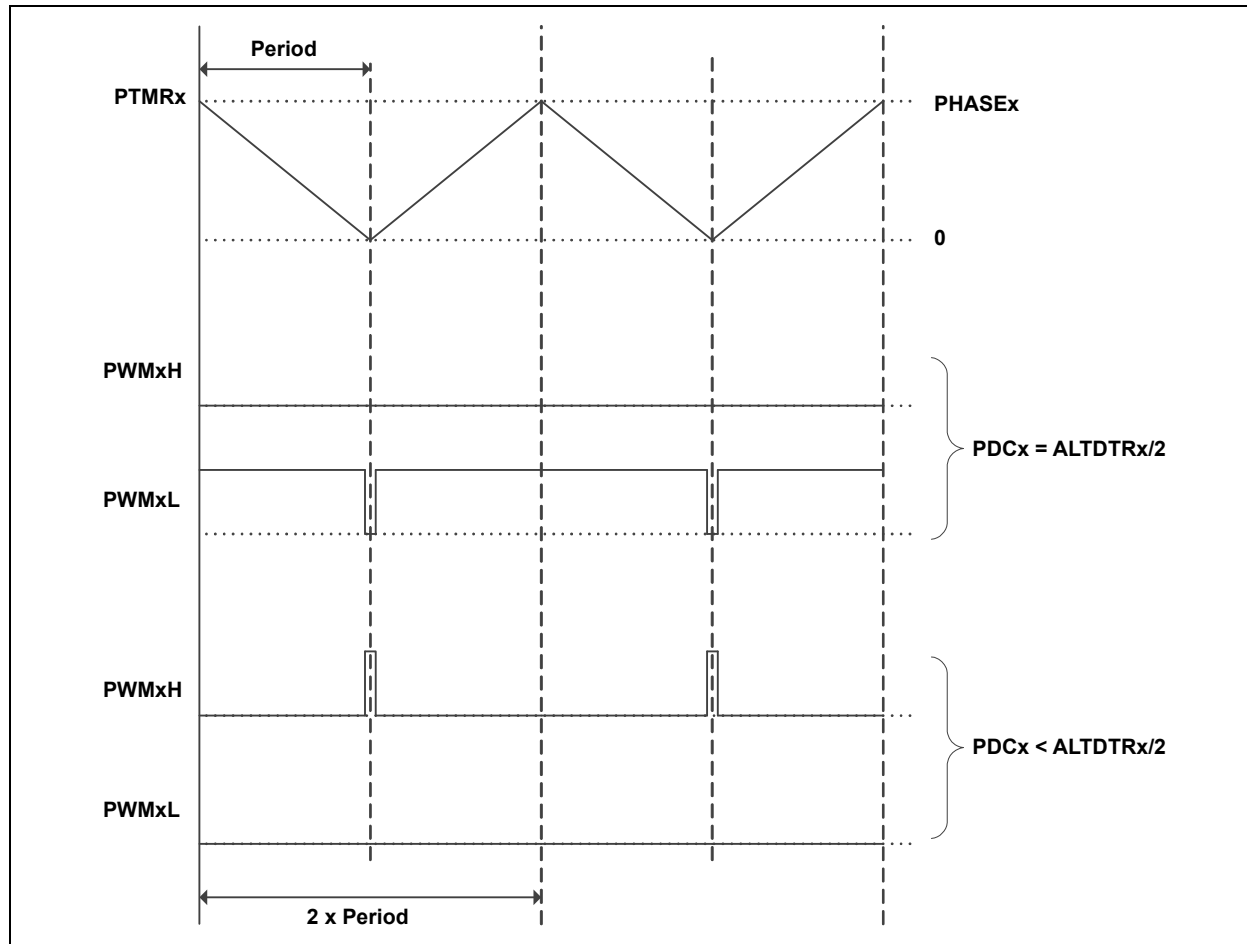
FIGURE 2: PWM GENERATOR TIMING DIAGRAM

In Center-Aligned Complementary mode with Independent Time Base, if the value in the PDCx register is less than one-half the value in the ALTDTRx register, the PWM generator will force the PWMxL to low, and on the PWMxH, generate pulses of width less than twice the dead time, as shown in [Figure 2](#).

Include a software routine to ensure that the duty cycle value written to the PDCx register is always at least one-half of the value in ALTDTRx. [Example 2](#) shows one method, with PDCtemp representing the variable which has the value to be written to the PDCx register. Alternatively, for duty cycle values less than half the desired dead-time value, zero out the ALTDTRx register or dynamically reduce the value in the ALTDTRx register, such that ALTDTRx is always equal to 2 * PDCx, as shown in [Example 3](#).

```
Altdtr_by2 = ALTDTRx / 2;
if (PDCtemp < Altdtr_by2)
{
    PDCx = Altdtr_by2;
}
else
{
    PDCx = PDCtemp;
}
```

```
#define DESIRED_DEADTIME 100
if (PDCtemp < (DESIRED_DEADTIME/2))
{
    ALTDTRx = PDCtemp * 2;
    PDCx = PDCtemp;
}
else
{
    ALTDTRx = DESIRED_DEADTIME;
    PDCx = PDCtemp;
}
```

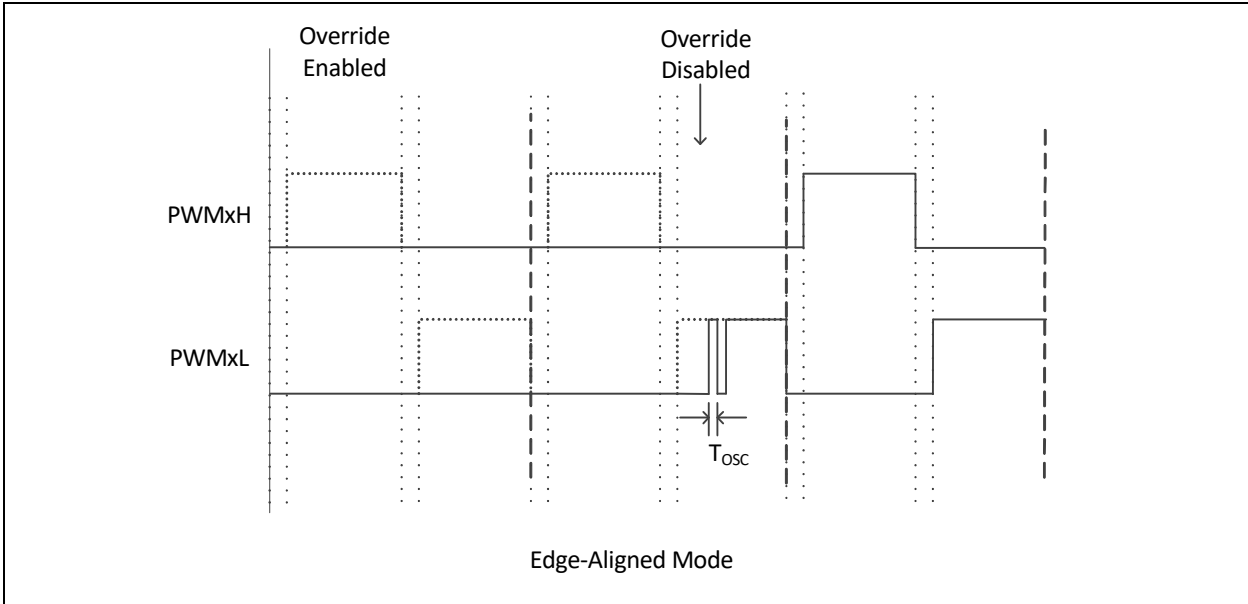
FIGURE 3: ILLUSTRATION OF 1 T_{osc} GLITCH WHEN PWM OVERRIDE IS TURNED OFF

In Complementary mode after the PWMx module is enabled (PTEN = 1), if the PWM override is turned off, a 1 T_{osc} glitch will be present on the rising edge of either PWMxH or PWMxL, whichever occurs first, as shown in Figure 3. The glitch will be present on PWMxH/PWMxL every time the override state is changed from enabled to disabled. The width of this glitch is equal to 1 T_{osc} when PCLKDIV[2:0] = 000; increasing the PWM input clock prescaler setting will increase the width of the glitch accordingly.

Since the width of the glitch is just 1 T_{osc} at higher values of F_{osc}, the glitch may not be visible on the PWMxH/PWMxL pins due to pin and PCB trace capacitances.

None.

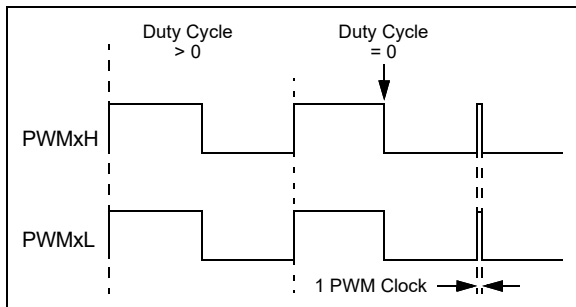
FIGURE 4:

In certain output modes, the PWMx module produces a pulse glitch of one PWM clock in width (Figure 4). This has been observed only when all of the following are true:

- Either Redundant or Push-Pull Output mode is selected (IOCONx[11:10] = 10 or 01);
- Immediate Update is disabled (PWMCONx[0] = 0); and
- The value of the current Duty Cycle register (either the PDCx or MDC register, as determined by PWMCONx[8]) is updated to zero from any non-zero value.

The pulse glitch has been observed to occur at the beginning of the following PWM boundary period.

If the application requires a duty cycle of zero, two possible work arounds are available.

1. Use the PWM overrides to force the output to a low state instead of writing a '0' to the Duty Cycle register. When using this method, the PWM override must be disabled when the duty cycle is a non-zero value. If output override synchronization is configured to occur on CPU clock boundaries (IOCONx[0] = 0), enabling and disabling the override must be timed to occur as closely as possible to the PWM period boundary.
2. Configure the module for Immediate Update (PWMCONx[0] = 1) *before* enabling the module. In this mode, writes to the Duty Cycle register have an immediate effect on the output. As with the previous work around, writes to the Duty Cycle register must be timed to occur as close to the PWM period boundary as possible in order to avoid distortion of the output.

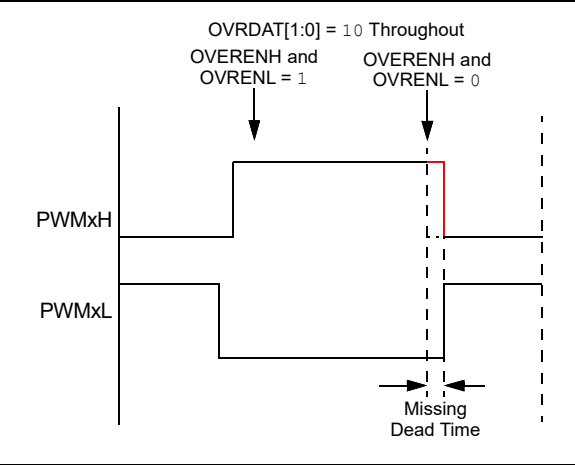
FIGURE 5:

In Complementary Output mode, the expected dead time between transitions of the PWMxH and PWMxL outputs may not be asserted when the following occurs:

- Output override synchronization is configured to occur on the CPU clock boundary (IOCONx[0] = 0);
- Both PWMxH and PWMxL overrides are enabled prior to the event (OVRENH and OVRENL are both '1'); and
- Both overrides are disabled (OVRENH and OVRENL are both '0') at the instant the dead time should be asserted (Figure 5).

This has been observed in both Center-Aligned and Edge-Aligned modes.

None.

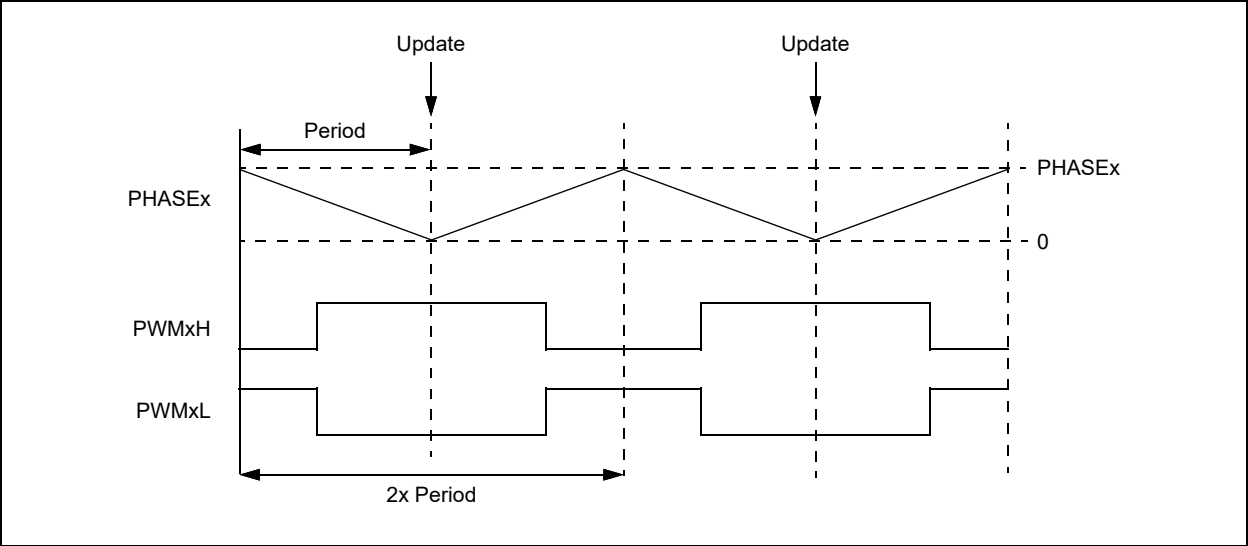
FIGURE 6:

In Center-Aligned Complementary mode with Independent Time Base, updates to the PHASEx register take effect in the middle of a center-aligned PWM cycle, as shown in Figure 6. This occurs only when the Immediate Update feature is disabled (IUE = 0). If Immediate Update is enabled (IUE = 1), the PHASEx register updates will take effect immediately.

None.
