## Product Change Notification: SYST-22EELM397

PIC18F06/16Q41 Silicon Errata and Data Sheet Clarifications

Added silicon errata issue 1.10.1.

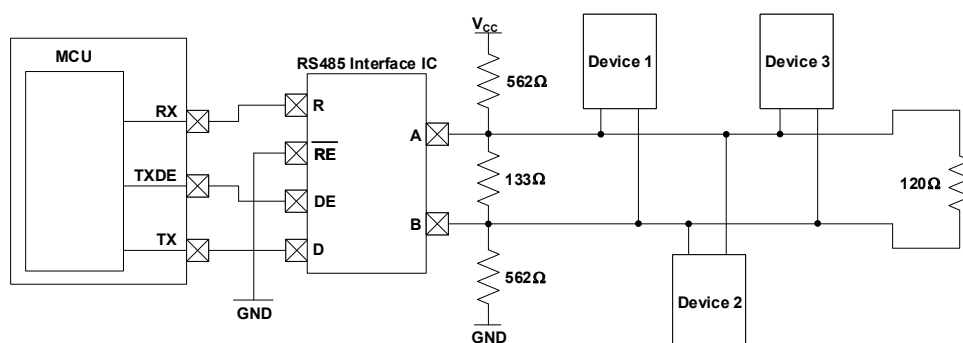
### 1.5.1. UART TXDE Signal May Go Low Before the STOP Bit Has Been Entirely Transmitted

The UART Transmit Drive Enable (TXDE) signal could potentially transition into a low state before the UART Stop bit has been entirely transmitted due to the effects of parasitic capacitance on the TX line. In some applications, this could result in communication being prematurely terminated due to the TXDE signal going low before the STOP bit has had enough time to settle.

To ensure that the Stop bit settles into its final logic state before the TXDE signal transitions low, a biasing circuit can be implemented. A biasing circuit allows the TX line to either be driven high or low, rather than being left in a floating tri-state mode, where prolonged rise or fall times could lead to communication being disrupted. This bias circuit must only be implemented on one end of the serial bus, and a termination resistor must be used on the other end. The figure below shows an example of a bias circuit that can be used to achieve this.

Please note that the resistor values used in this circuit are recommendations and that the actual resistor values required may vary based on the application.
