## Product Change Notification: SYST-02PZSA903

dsPIC33EVXXXGM00X/10X Family Silicon Errata and Data Sheet Clarification

Revision X Document (6/2026)

Adds data sheet clarification 7 (10-Bit/12-Bit Analog-to-Digital Converter (ADC)) and 8 (Electrical Characteristics).

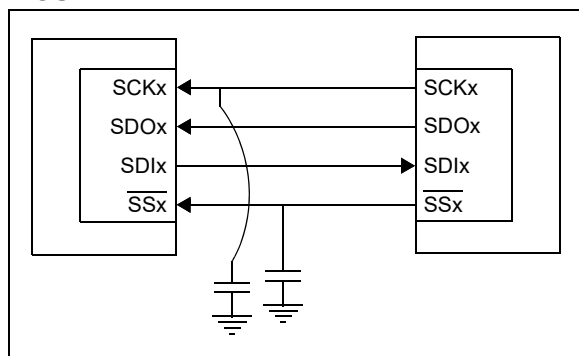
FIGURE 1:

Adding a capacitance on the signal, as shown in Figure 1, will help the data to be received properly.

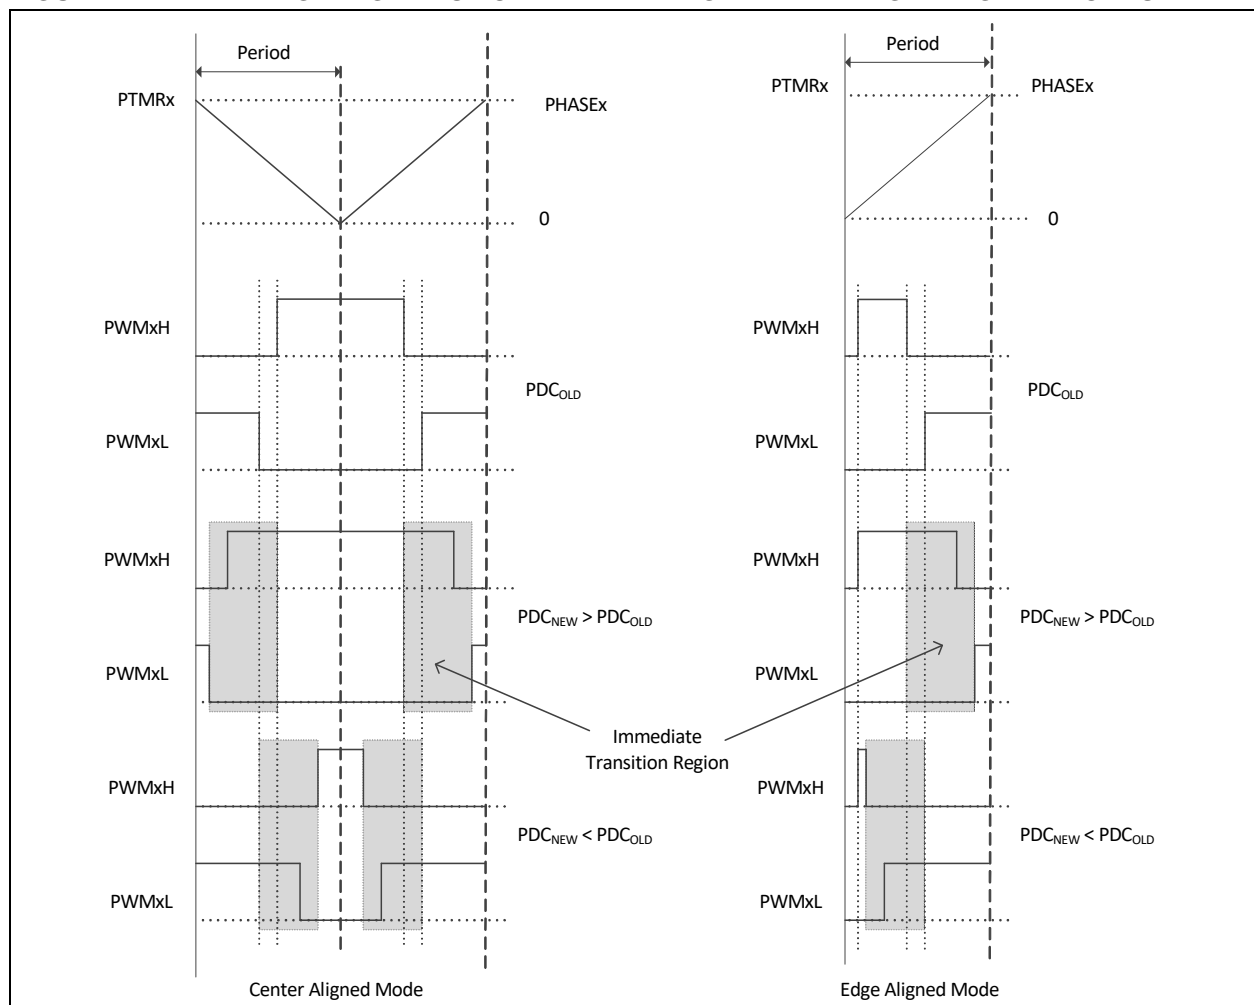
**FIGURE 2: TIMING DIAGRAMS FOR CENTER-ALIGNED AND EDGE-ALIGNED MODES**

The PWM generator may not assert dead time on the edges of transitions. This has been observed when all of the following conditions are present:

In [Figure 2](#), if the duty cycle write occurred in the shaded box, then PWMxH and PWMxL will make an immediate transition without dead time.

None.

However, in most applications, the duty cycle update timing can be controlled using the TRIGx trigger or Special Event Trigger, such that the above mentioned conditions are avoided altogether.

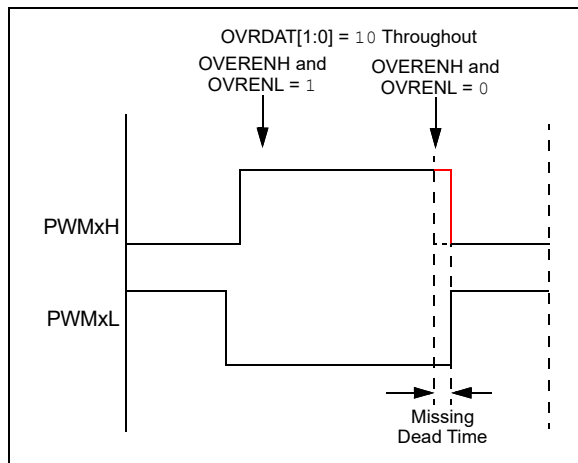
FIGURE 4:

- Output override synchronization is configured to occur on the CPU clock boundary (IOCONx[0] = 0);
- Both PWMxH and PWMxL overrides are enabled prior to the event (OVRENH and OVRENL are both '1'), and
- Both overrides are disabled (OVRENH and OVRENL are both '0') at the instant the dead time should be asserted (Figure 4). This has been observed in both Center-Aligned and Edge-Aligned modes.

None.

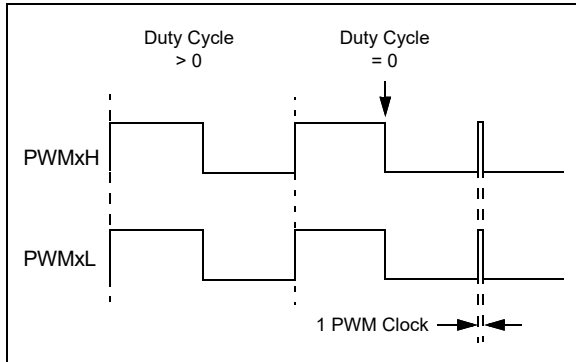
FIGURE 5:

In the Redundant Output mode (IOCONx[11:10] = 10) and Push-Pull Output mode (IOCONx[11:10] = 01) with Immediate Update disabled (PWMCONx[0] = 0), when the Duty Cycle register is updated from a non-zero value to zero, a glitch pulse of a width equal to one PWM clock will appear at the next PWM period boundary, as shown in Figure 5, for the Redundant Output mode. Here, the Duty Cycle register refers to the PDCx register if PWMCONx[8] = 0 or the MDC register if PWMCONx[8] = 1.

If the application requires a zero duty cycle output, there are two possible work around methods:

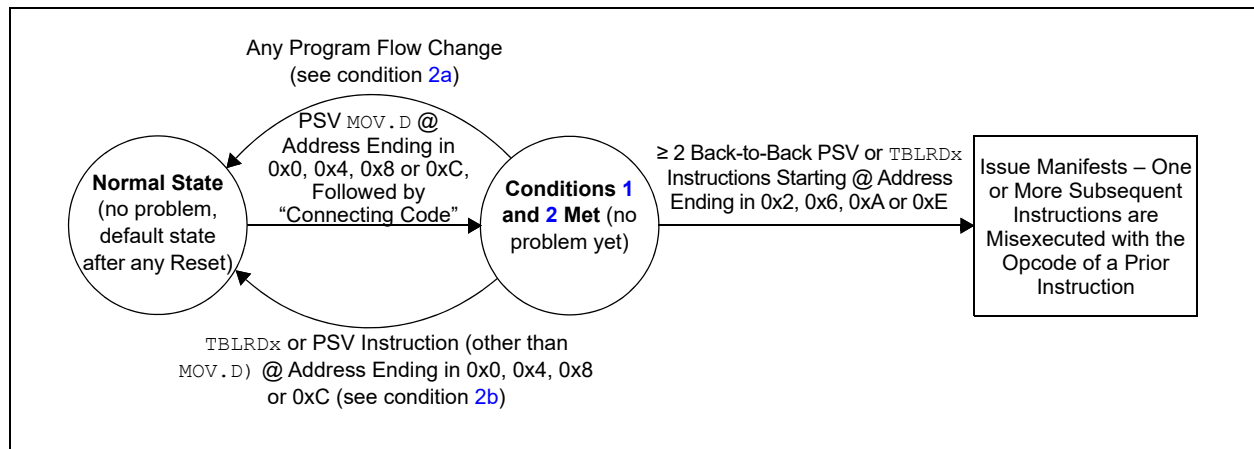
**FIGURE 7: SIMPLIFIED BEHAVIOR**

When two or more data Flash read instructions (via Program Space Visibility (PSV) read or table read) are executed back-to-back, one or more subsequent instructions can be misexecuted when all of the conditions in [Table 6](#) occur.

| 3. | ≥ 2 back-to-back PSV or <code>TBLRDx</code> instructions are executed (following the code of condition 2), where the first of the back-to-back instructions is located at an address ending in 0x2, 0x6, 0xA or 0xE. |

[Figure 7](#) provides an example of the effective behavior.

1. All instances of PSV MOV.D can be replaced with two PSV MOV instructions instead. Non-PSV MOV.D instructions acting on RAM/SFRs do not need to be modified; or
2. If not already present, a program flow change instruction (such as BRA \$+2) can be inserted above back-to-back data Flash read sequences; or
3. Back-to-back data Flash read instruction sequences can be broken up by inserting a non-Flash read instruction (such as a NOP), in between the Flash read instructions; or
4. The alignment of the code can be shifted to avoid the required opcode location addresses.
