## Product Change Notification: SYST-17HGRB251

dsPIC33AK256MPS306 Family Silicon Errata and Data Sheet Clarification

SYST-17HGRB251

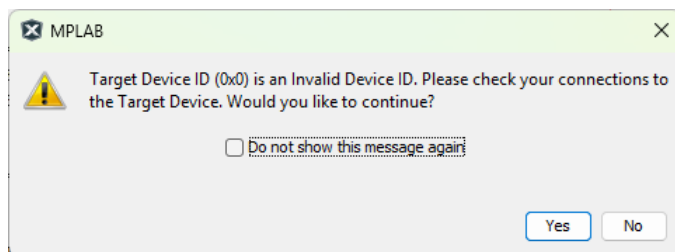
**Figure 1.** Example of Incorrect DEVID from MPLAB X IDE

If the power monitor module is enabled via the FPWRM configuration bit, during device programming/ICSP entry, the power monitor may trigger a reset event during the loading of the configuration fuses, and as a result, an incorrect DEVID message may appear.

Select **Yes** in the message prompt or the equivalent of 'Yes' in the programming environment, and the device will program as expected.
