## Product Change Notification: SYST-17ZCED145

PIC18F27/47/57Q84 Silicon Errata and Data Sheet Clarifications

SYST-17ZCED145

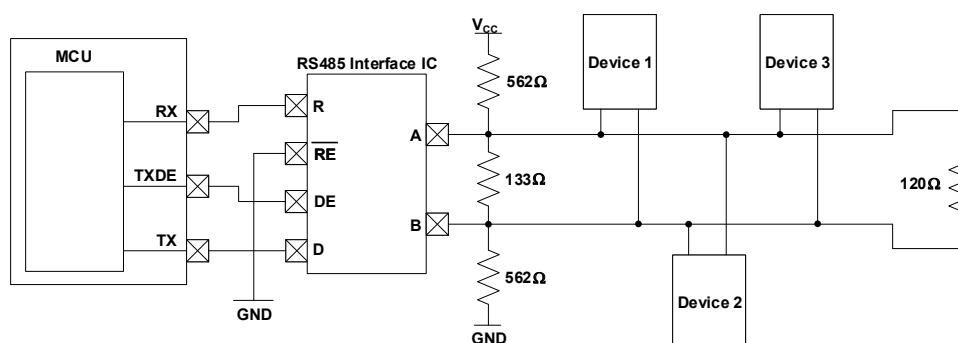
To ensure that the Stop bit settles into its final logic state before the TXDE signal transitions low, a biasing circuit can be implemented. A biasing circuit allows the TX line to either be driven high or low, rather than being left in a floating tri-state mode, where prolonged rise or fall times could lead to communication being disrupted. This bias circuit must only be implemented on one end of the serial bus, and a termination resistor must be used on the other end. The figure below shows an example of a bias circuit that can be used to achieve this.

Please note that the resistor values used in this circuit are recommendations and that the actual resistor values required may vary based on the application.
