## Product Change Notification: SYST-17GFQM067

PIC18F26/46/56Q84 Silicon Errata and Data Sheet Clarifications

SYST-17GFQM067

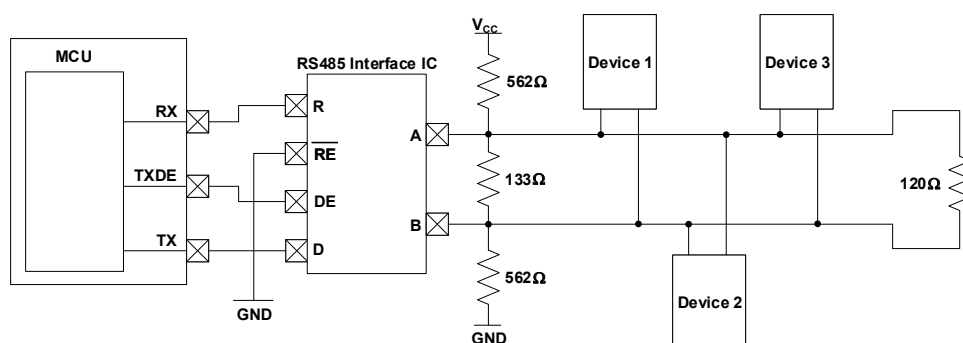
### 1.6.1. UART TXDE Signal May Go Low Before the STOP Bit Has Been Entirely Transmitted

The UART Transmit Drive Enable (TXDE) signal could potentially transition into a low state before the UART Stop bit has been entirely transmitted due to the effects of parasitic capacitance on the TX line. In some applications, this could result in communication being prematurely terminated due to the TXDE signal going low before the STOP bit has had enough time to settle.

To ensure that the Stop bit settles into its final logic state before the TXDE signal transitions low, a biasing circuit can be implemented. A biasing circuit allows the TX line to either be driven high or low, rather than being left in a floating tri-state mode, where prolonged rise or fall times could lead to communication being disrupted. This bias circuit must only be implemented on one end of the serial bus, and a termination resistor must be used on the other end. The figure below shows an example of a bias circuit that can be used to achieve this.

Please note that the resistor values used in this circuit are recommendations and that the actual resistor values required may vary based on the application.
