## Product Change Notification: SYST-170WAE192

PIC18F27/47/57Q83 Silicon Errata and Data Sheet Clarifications

### **PIC18F27/47/57Q83 Silicon Errata and Data Sheet Clarifications**

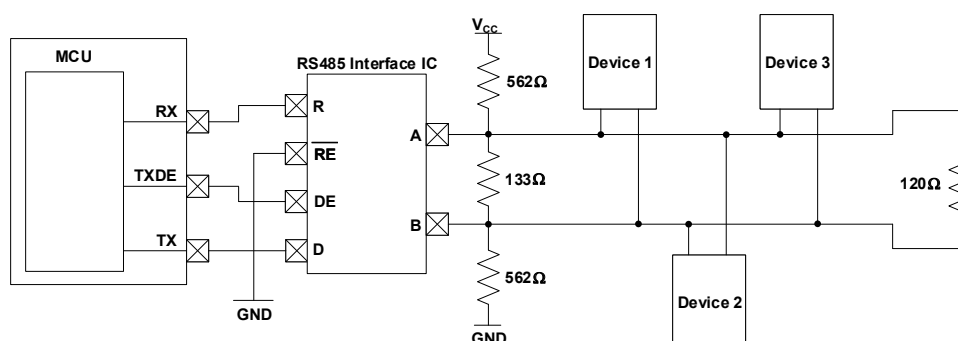
### 1.6.1. UART TXDE Signal May Go Low Before the STOP Bit Has Been Entirely Transmitted

To ensure that the Stop bit settles into its final logic state before the TXDE signal transitions low, a biasing circuit can be implemented. A biasing circuit allows the TX line to either be driven high or low, rather than being left in a floating tri-state mode, where prolonged rise or fall times could lead to communication being disrupted. This bias circuit must only be implemented on one end of the serial bus, and a termination resistor must be used on the other end. The figure below shows an example of a bias circuit that can be used to achieve this.

Please note that the resistor values used in this circuit are recommendations and that the actual resistor values required may vary based on the application.
