Product Change Notification / SYST-15MAVS007

ERRATA - ATtiny87/167 Automotive Silicon Errata and Data Sheet Clarifications

Automotive Silicon Errata and Data Sheet Clarifications

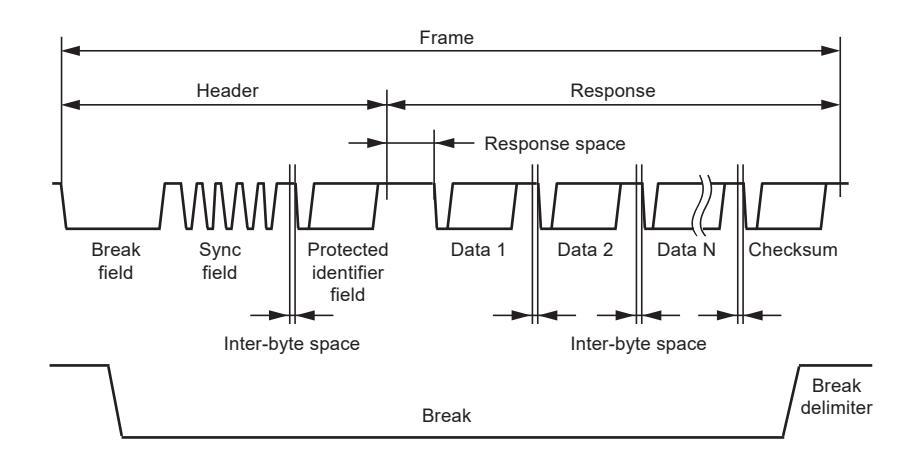
Figure 2-1. The Break Field

In SLAVE MODE, a BREAK field detection error can occur under the following conditions.

The problem occurs if two conditions occur simultaneously:

- 1. The DOMINANT part of the BREAK is (N+0.5)*Tbit long with N=13, 14,15, ...
- 2. The RECESSIVE part of the BREAK (BREAK DELIMITER) is equal to 1*Tbit. (See the note below).

The BREAK_high is not detected, and the 2nd bit of the SYNC field is interpreted as the BREAK DELIMITER. The error is detected as a framing error on the first bits of the PID or subsequent Data or a Checksum error.

There is no error if BREAK_high is greater than 1 x Tbit + 18%.

Note: LIN2.1 protocol specification paragraph 2.3.1.1 Break field says (www.microchip.com/mymicrochip/ filehandler.aspx?ddocname=en590544): "A break field is always generated by the master task (in the master node) and it shall be at least 13 nominal bit times of dominant value, followed by a break delimiter, as shown in Figure 2-1. The break delimiter shall be at least one nominal bit time long."

None
