## Product Change Notification / SYST-25YQMY847

ERRATA - PIC16(L)F15325/45 Family Silicon Errata and Data Sheet Clarification Errata Document Revision

## PIC16(L)F15325/45 Family Silicon Errata and Data Sheet Clarification

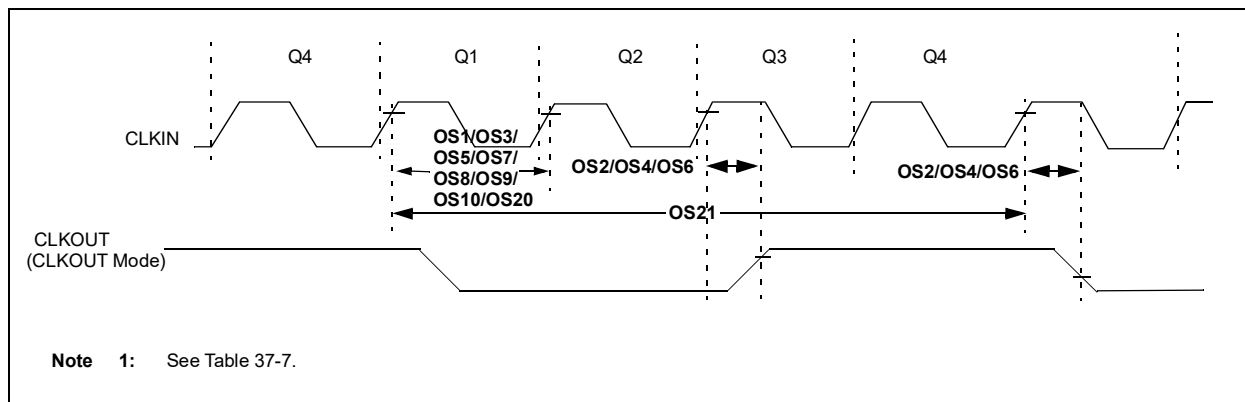
#### 2.1 Figure 37-5: Clock Timing

Figure 37-5 incorrectly shows the location of parameters OS1, OS2, OS3, OS4, OS5, OS6, OS7, OS8, OS9, OS10, OS20 and OS21. The correct location for the above-mentioned parameters is depicted in the following figure.

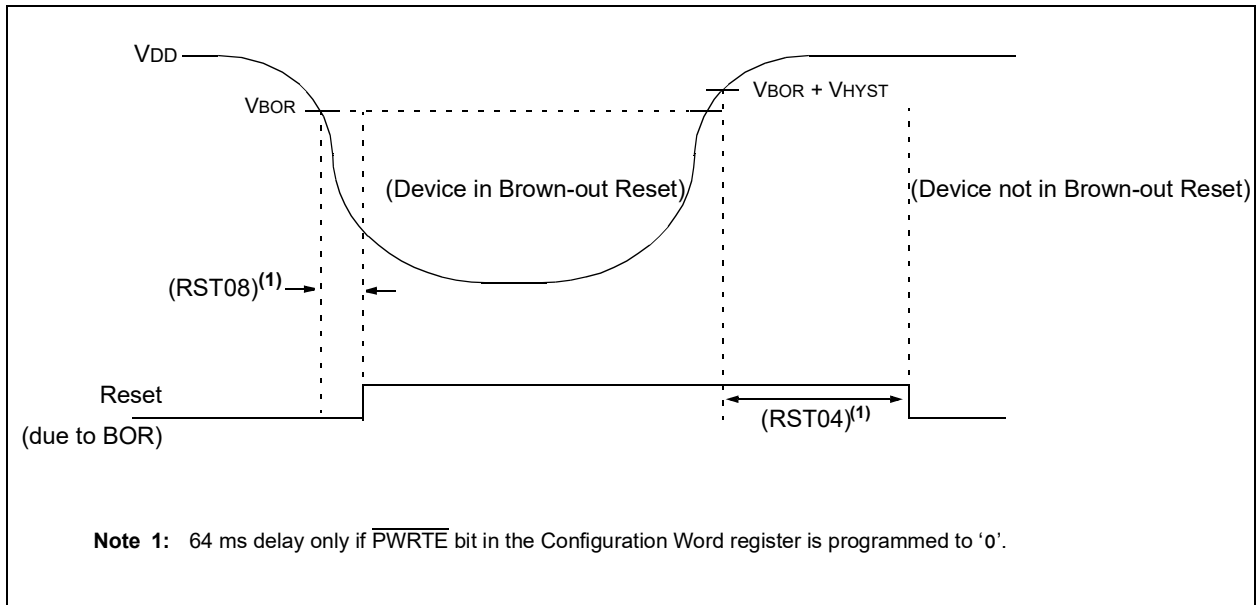
#### 2.2 Figure 37-9: Brown-Out Reset Timing and Characteristics

Note 1 in Figure 37-9 is incorrect. The correct note along with the figure is depicted below.
