# Practical guide Thermography for heating contractors.

How thermal imagers from Testo can help you to reduce costs and increase sales.

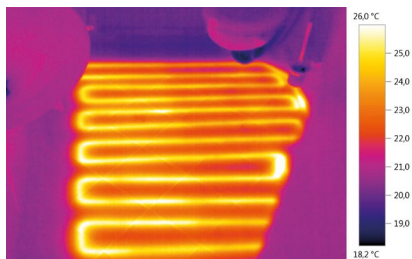
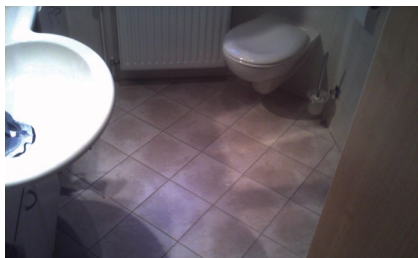
In order to locate a leak in the heating system pipework, the first task is to trace where the pipes run. The time for this can be considerably reduced by using a thermal imager from Testo:

- The area to be examined is restricted to the relevant section.
- Thanks to the good visibility in the thermal image, the course of the pipework can be easily and conveniently traced (cf. adjacent illustration).

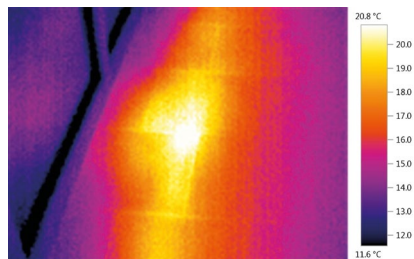
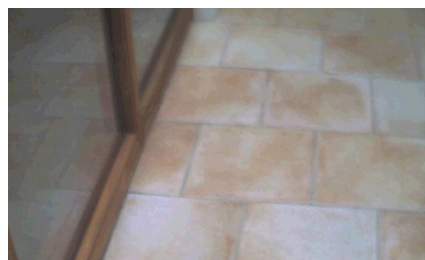
Once the thermal imager has established the pipework runs, efforts can be focused on locating the leak. The image on the right depicts the thermal survey of a glazed walkway between a lounge and kitchen extension. The homeowner is complaining of occasional water leakage under the tiled floor. The thermal image shows the heat pattern effect from the heating pipes running under the walkway. At one point they clearly exhibit increased temperature concentration. This hot spot indicates a possible leak from the central heating system. Leaks are usually identifiable by an irregular-shaped hot spot. With the help of thermal images, the possible location of the problem in the heating pipe could be detected.

Further examinations proved that there was in fact a leak at this location.

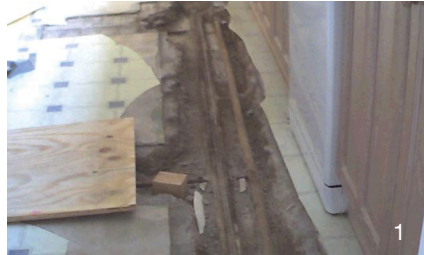
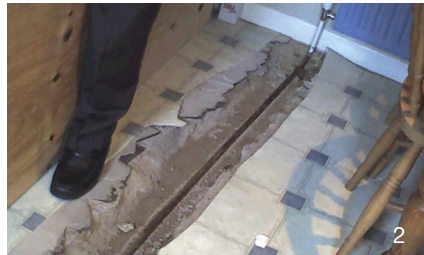
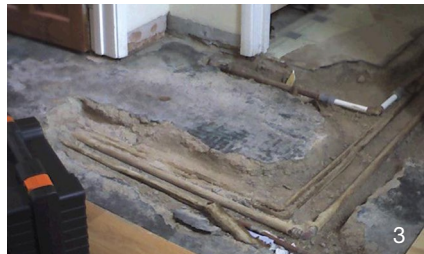
Figures 1 –3 are taken from a thermal survey conducted in conjunction with an ongoing investigation, in relation to a suspected water leak at the property.

- In order to find the leak, large areas of flooring were unnecessarily broken open.
- It took three days to find the leak.
- Considerable work and material costs were incurred in putting everything back into its original condition.

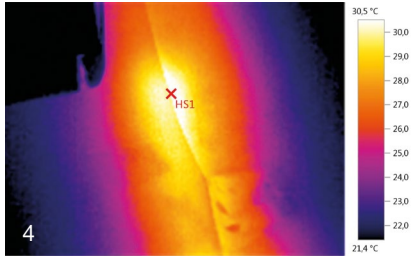
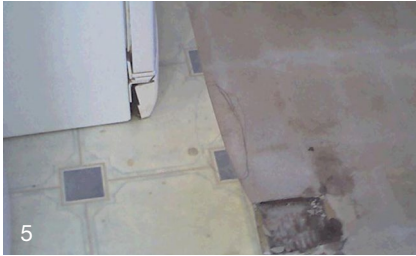
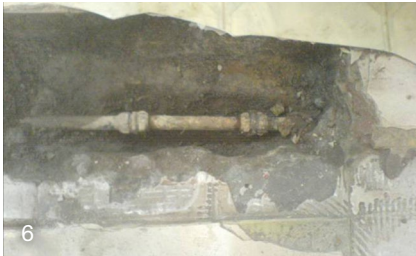
In this instance, Testo were asked to use a thermal imager to prove the existence of the leak where more conventional methods had failed. The instruments testo 865s testo 868s, testo 871s and testo 872s are best suited to this area of application. The course of the pipework could be traced beyond the exposed areas. To the frustration of the contractors

involved, the camera very quickly detected a hot spot and, after a short period of time, the hot spot began to expand, which was a good indication of a possible leak (fig. 4–5). Having located the leak, the contractor was able to expose this small section of the pipework and the leaking section of pipework was located (see fig. 6).

In the case described here, the thermal imager used was a testo 872s, with up to 320 x 240 pixels and < 50 mK thermal resolution.

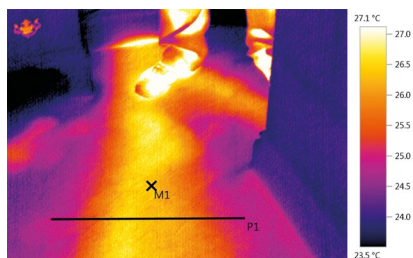
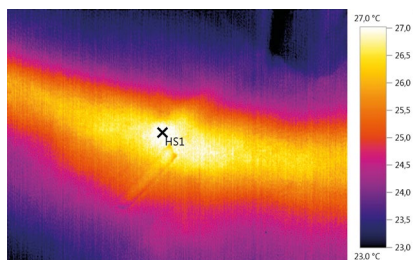
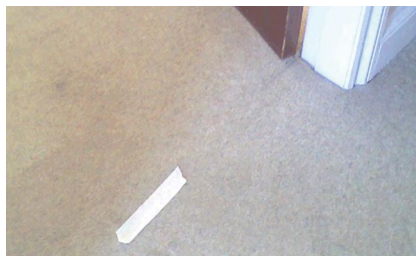
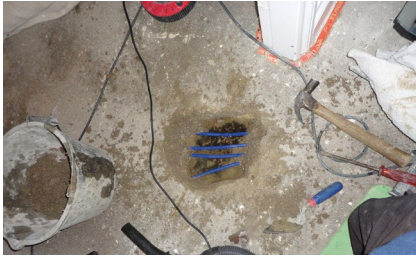
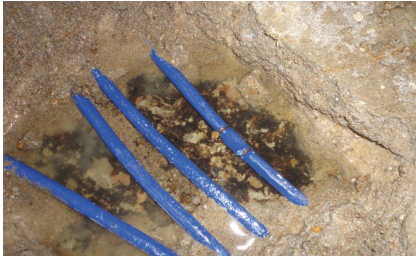
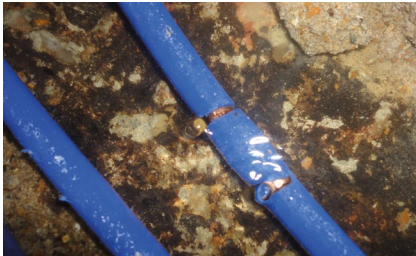
In another instance, a heating company's customer had a problem with his heating system. The water level constantly needed topping up, which was an indication of a leak somewhere in the system. The heating was switched on and, after a short period of time, the testo 872s thermal imager was used to inspect the heating system pipework and check the various pipework runs for any leaks. Almost immediately, a hot spot was identified in the doorway between the hall and the lounge, indicating a probable leak. The hot spot was marked with masking tape for future reference, when the carpets would be lifted and an inspection hole dug to check this section of the floor. The pinpointed leak location proved to be correct. The hot spot had identified the leak on a microbore heating system, where the pipes were running approximately 70–90 mm beneath concrete screed and a substantial carpet with rubberised underlay. The testo 872s thermal imager enabled this heating contractor to inspect the heating system pipework

and identify the leak quickly and easily. This provided considerable savings in terms of the time and cost needed to locate the leak, and the customer also benefited from major savings in terms of cost and disruption. The capability of the 320 x 240 pixel resolution is fully

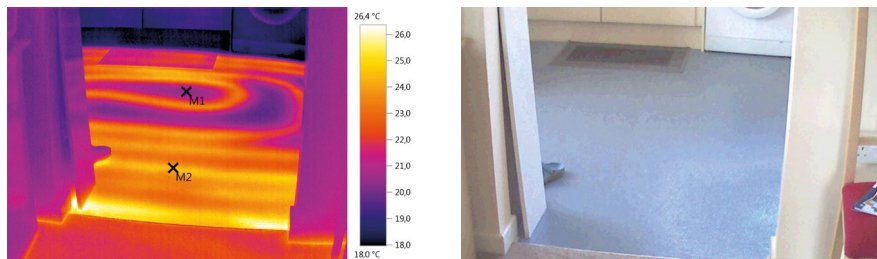
A thermal imager instantly visualizes the condition of the underfloor heating system. It moreover gives an indication of the surface temperature of the floor, which is also indicative of the heating system's performance.

From the images it is evident that the underfloor heating system is not functioning efficiently. We can clearly see exactly where it is working and where it is not working. This is shown via the temperature distribution in the thermal image.

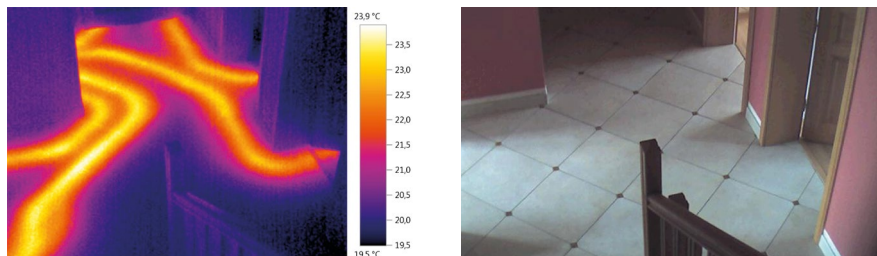
The thermal inspection can be used to indicate temperatures across the heating coils and to highlight any temperature variation across the floor. A thermal imager can also be used to give a visual indication of what is happening at the supply and return manifold. Large variations in return temperatures indicate that there could be a problem with the system.

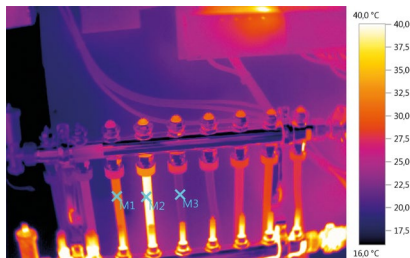
Measurement object	Temp °C
Measure point 1	30.5
Measure point 2	40.2
Measure point 3	22.2

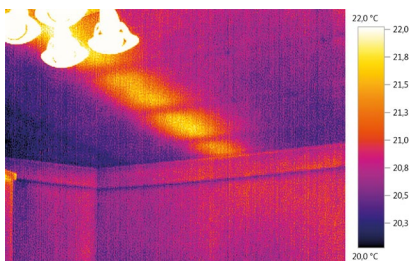
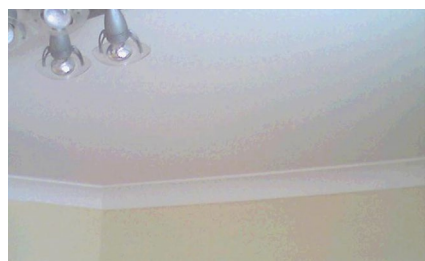
A Testo thermal imager will provide with clear information. The location of the concealed flue can clearly be identified in the thermal image below, running in the cavity above the ceiling in an apartment. Having established where the concealed flue runs, the positions for inspection hatches can be marked and subsequently cut, and the hatches installed. Without a thermal imager, it would not have been possible to visually locate the exact position of the concealed flue.
