Product Change Notification / SYST-31HPWF472

ERRATA - dsPIC33CH128MP508 Family Silicon Errata and Datasheet Clarification

dsPIC33CH128MP508 Family Silicon Errata and Data Sheet Clarification

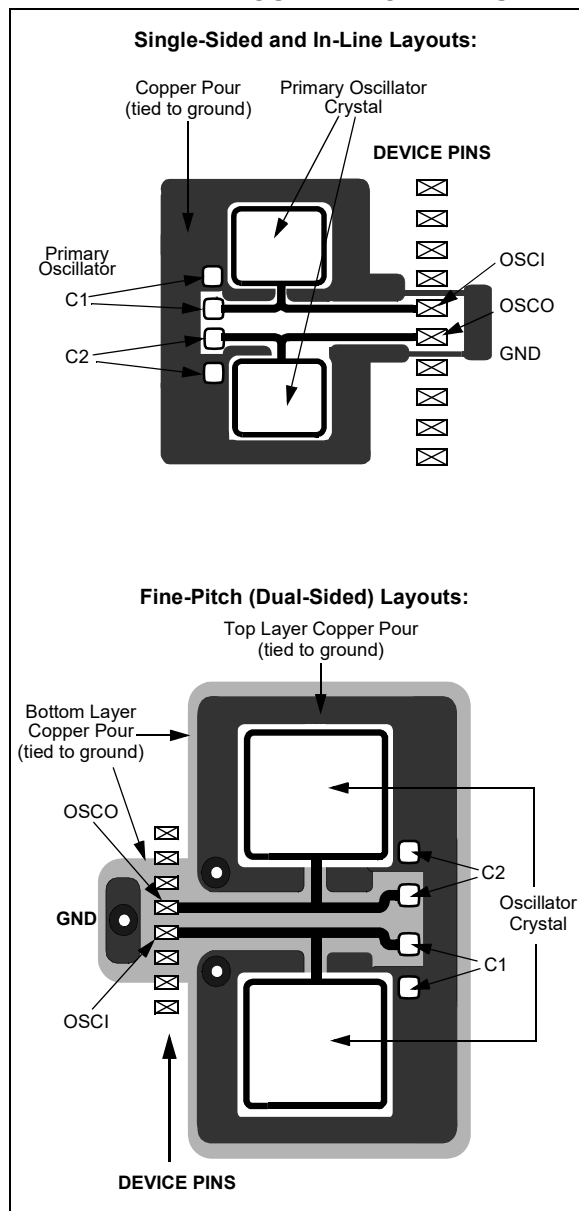
FIGURE 2-2: SUGGESTED PLACEMENT OF THE OSCILLATOR CIRCUIT

Use best practices during PCB layout to ensure robust start-up and operation. The oscillator circuit should be placed on the same side of the board as the device. Also, place the oscillator circuit close to the respective oscillator pins, not exceeding one-half inch (12 mm) distance between them. The load capacitors should be placed next to the oscillator itself, on the same side of the board. Use a grounded copper pour around the oscillator circuit to isolate it from surrounding circuits. The grounded copper pour should be routed directly to the MCU ground. Do not run any signal traces or power traces inside the ground pour. If using a two-sided board, avoid any traces on the other side of the board where the crystal is placed. Suggested layouts are shown in [Figure 2-2](#). With fine-pitch packages, it is not always possible to completely surround the pins and components. A suitable solution is to tie the broken guard sections to a mirrored ground layer. In all cases, the guard trace(s) must be returned to ground.

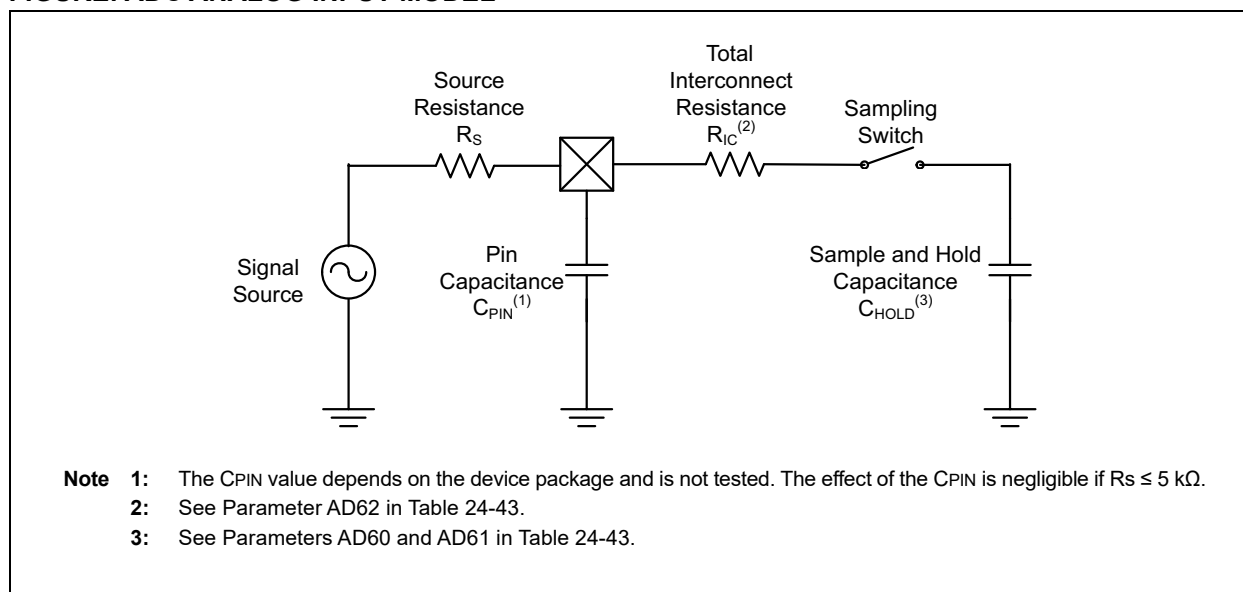
FIGURE: ADC ANALOG INPUT MODEL

The total acquisition time for the Analog-to-Digital conversion is a function of the Holding Capacitor (C_{HOLD}) charge time. For the ADC module to meet its specified accuracy, the Holding Capacitor (C_{HOLD}) must be allowed to fully charge to the voltage level on the analog input pin. The Signal Source Impedance (R_s)

and the Interconnect Impedance (R_{IC}) combine to affect the time required to charge the C_{HOLD} . The total resistance ($R_s + R_{IC}$) must therefore, be small enough to fully charge the Holding Capacitor within the selected sample time.
