Product Change Notification / SYST-23OUGH321

ERRATA - dsPIC33CH128MP508 Family Silicon Errata and Datasheet Clarification

dsPIC33CH128MP508 Family Silicon Errata and Data Sheet Clarification

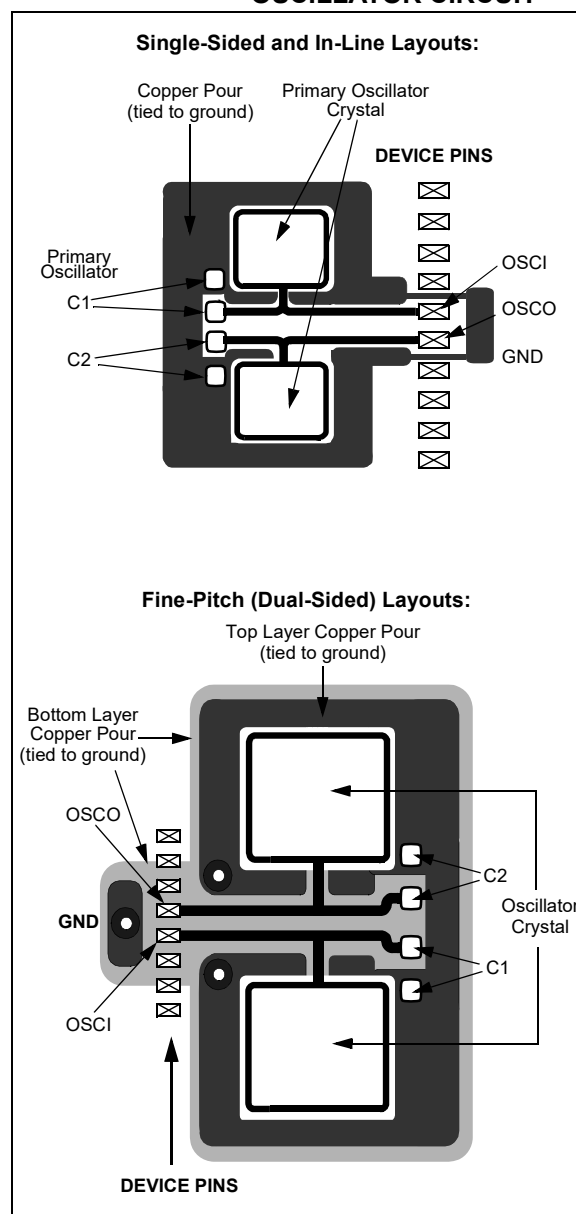
FIGURE 2-2: SUGGESTED PLACEMENT OF THE OSCILLATOR CIRCUIT

When the Primary Oscillator (POSC) circuit is used to connect a crystal oscillator, special care and consideration is needed to ensure proper operation. The POSC circuit should be tested across the environmental conditions that the end product is intended to be used. The load capacitors specified in the crystal oscillator data sheet can be used as a starting point, however, the parasitic capacitance from the PCB traces can affect the circuit and the values may need to be altered to ensure proper start-up and operation.

Use best practices during PCB layout to ensure robust start-up and operation. The oscillator circuit should be placed on the same side of the board as the device. Also, place the oscillator circuit close to the respective oscillator pins, not exceeding one-half inch (12 mm) distance between them. The load capacitors should be placed next to the oscillator itself, on the same side of the board. Use a grounded copper pour around the oscillator circuit to isolate it from surrounding circuits. The grounded copper pour should be routed directly to the MCU ground. Do not run any signal traces or power traces inside the ground pour. If using a two-sided board, avoid any traces on the other side of the board where the crystal is placed. Suggested layouts are shown in [Figure 2-2](#). With fine-pitch packages, it is not always possible to completely surround the pins and components. A suit-

able solution is to tie the broken guard sections to a mirrored ground layer. In all cases, the guard trace(s) must be returned to ground.
