## Product Change Notification: SYST-02PZSA903

dsPIC33EVXXXGM00X/10X Family Silicon Errata and Data Sheet Clarification

Revision X Document (6/2026)

Adds data sheet clarification 7 (10-Bit/12-Bit Analog-to-Digital Converter (ADC)) and 8 (Electrical Characteristics).

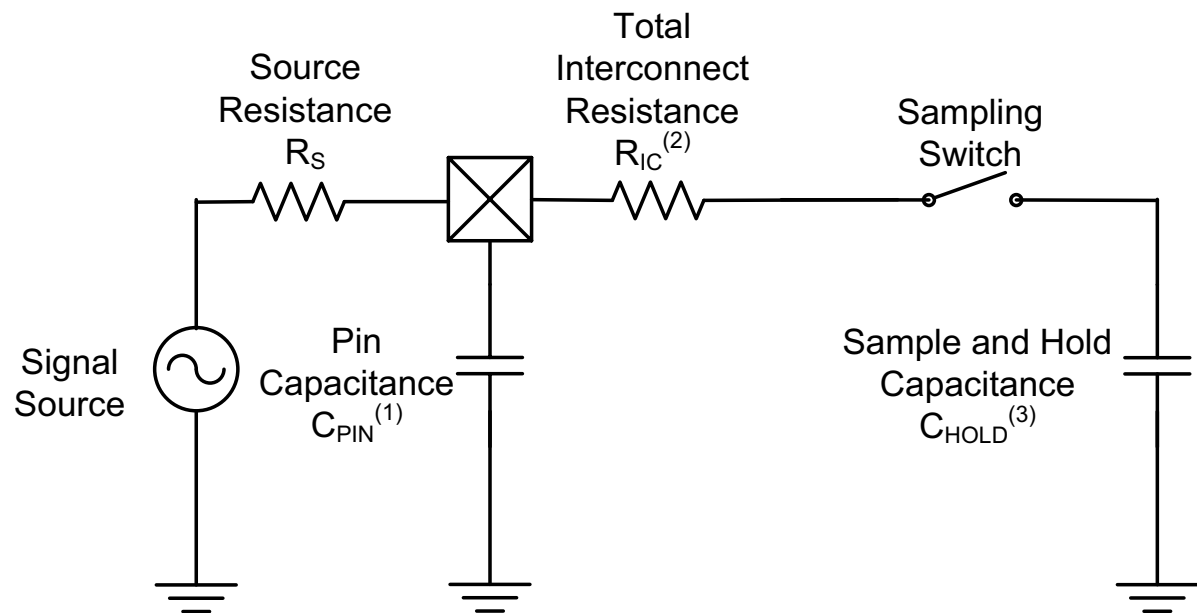
Figure 24-3. ADC Input Model

**Note 1:** The  $C_{PIN}$  value depends on the device package and is not tested. For QFN or TQFP packages, the typical value is about 4 pF.

**2:** The typical value of  $R_{IC}$  is less than 10 k $\Omega$ .
