## Product Change Notification / SYST-23UFEG663

Ethernet PHYs

ERRATA - KSZ9131RNX Silicon Errata and Data Sheet Clarification

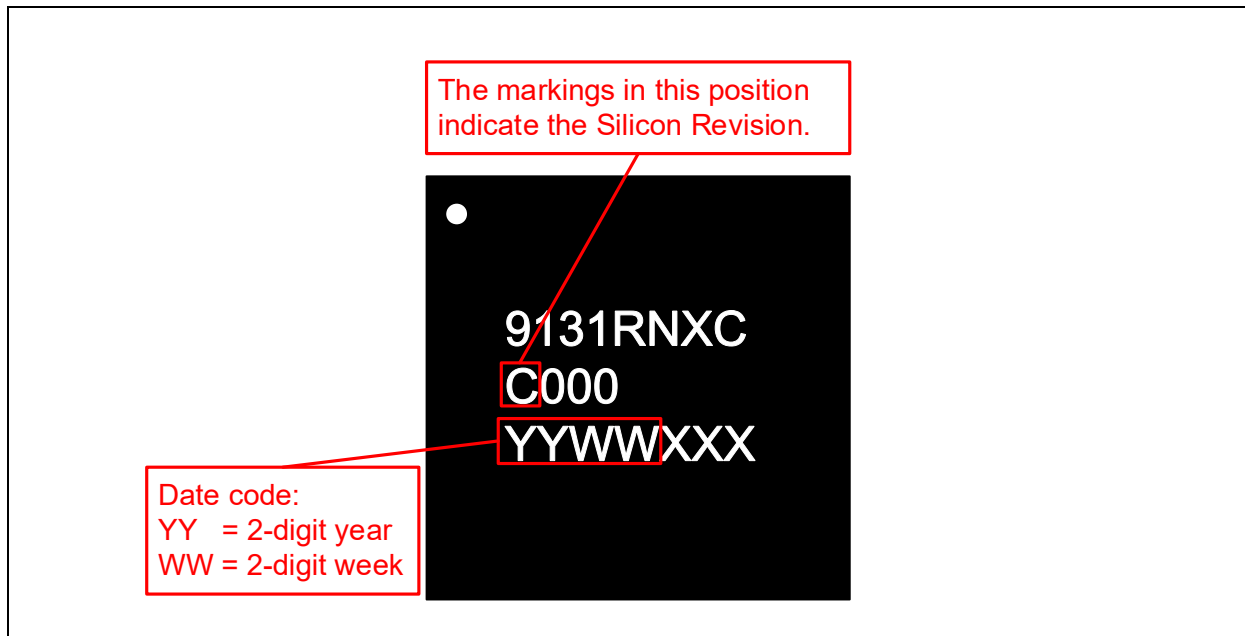
**FIGURE 1: TOP MARKING DATE CODE INDICATION**

**Note:** The purpose of [Figure 1](#) is to detail the top markings of an example part and highlight the location of the silicon revision code. Other top marking values may differ (lot codes, location of manufacture, etc.).

The silicon errata discussed in this document are for silicon revisions as listed in [Table 1](#). The silicon revision can be determined by the device's top marking as indicated in [Figure 1](#). A summary of KSZ9131RNX silicon errata is provided in [Table 2](#).

Revision Level & Date	Section/Figure/Entry	Correction
DS80000693C (02-23-22)	Module 3	Added <b>Module 3 : 1000M EEE needs 100M Advertisement Enabled</b>
	Table 1, Table 2, and Figure 1	Changed silicon revision letter from "C0" to "C."
DS80000693B (07-19-21)	Module 2	Added <b>Module 2 : LED1 in Single-LED Mode Behaves Incorrectly</b>
DS80000693A (10-21-19)	All	Initial release
