## Product Change Notification: SYST-300CGQ577

LAN8670/1/2 Errata

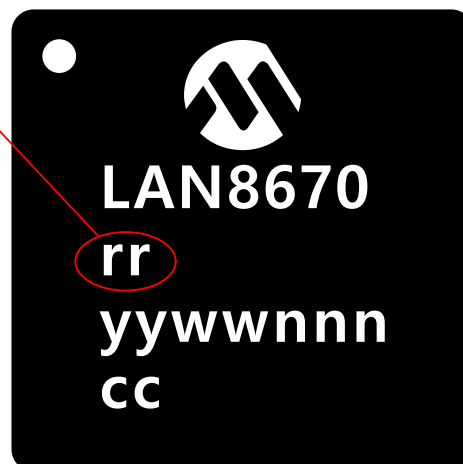
**Figure 1.** Top Marking for LAN8670 Device

Marking in this position  
indicates product revision

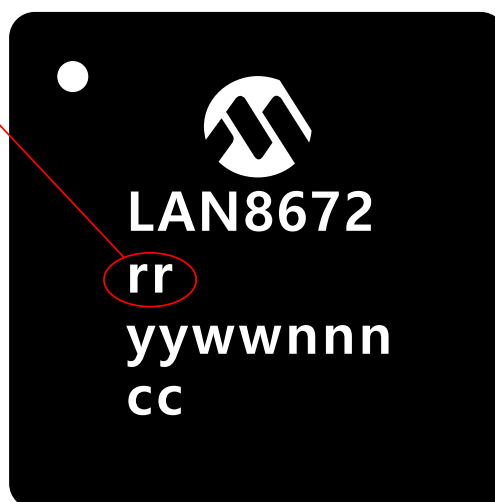
**Figure 3.** Top Marking for LAN8672 Device

Marking in this position  
indicates product revision
