# WISE-2410(X) Product Change Notice

## Product Firmware Bug Fix Announcement

We have identified an internal system time calibration failure in the WISE-2410 series firmware version A1.20.B00. This issue may occasionally cause the device to enter an unresponsive sleep state after running for a period of time, halting all scheduled data acquisition and transmission.

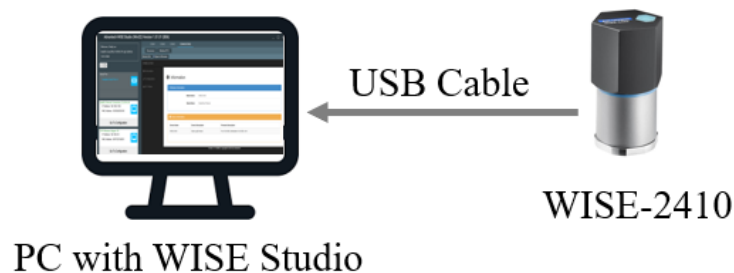
Figure. Topology of this document.

The document will be divided into three section to help the user to read. And the three sections are shown as below.

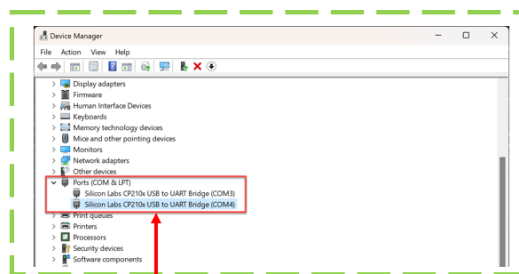
**Device Manager from Windows**

After installation, in Windows Device Manager, you should see device named “Silicon Labs CP210x USB to UART Bridge” follow with COM port it is using, in the screenshot below, it shows that there are two WISE nodes connected, and they are using COM3 and COM4.

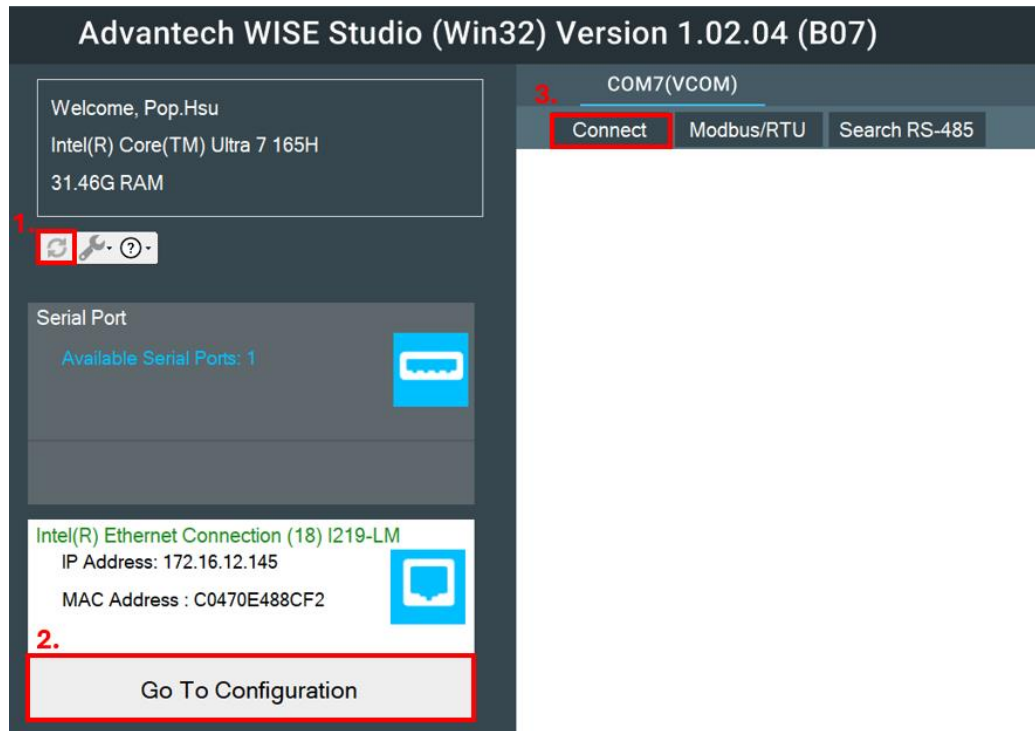
In WISE Studio, navigate to the connection settings and select the correct COM port to establish a link with your WISE-2410.

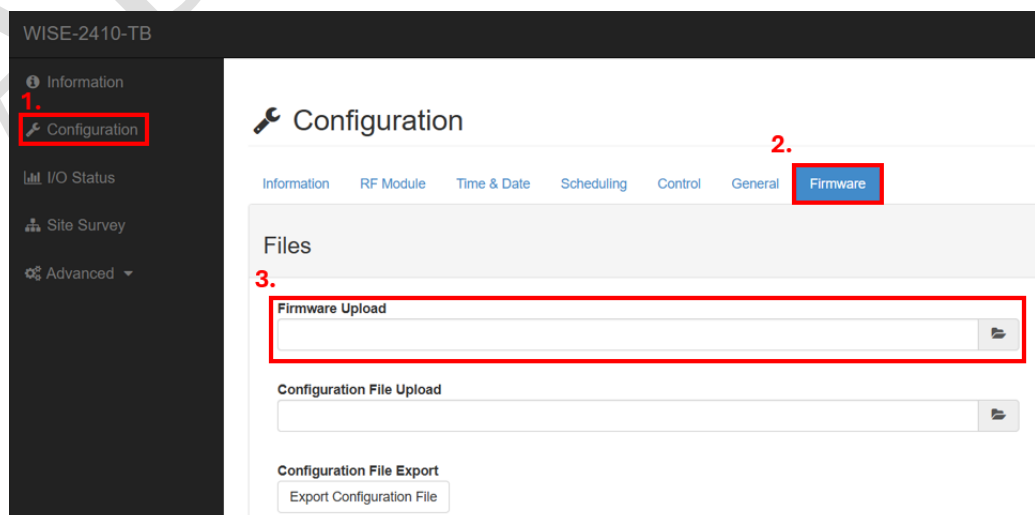
Navigate to the Firmware Upgrade page. Click "Browse" to select the firmware file you downloaded, and click "Start" to begin the process.

**Warning: Do not disconnect the USB cable or close the application during the upgrade process, as doing so may cause the device to become unresponsive.**
