| HIROSE<br>ELECTRIC<br>CO., LTD. | | | APPROVED : HS. OKAWA | | 13.03.13 | DRAWING NO. EDC3-347265-00 | | | |
| | | | CHECED : KI. HIROKAWA | | 13.03.12 | PART NO. FX30B-3P-3.81DSA30 | | | |

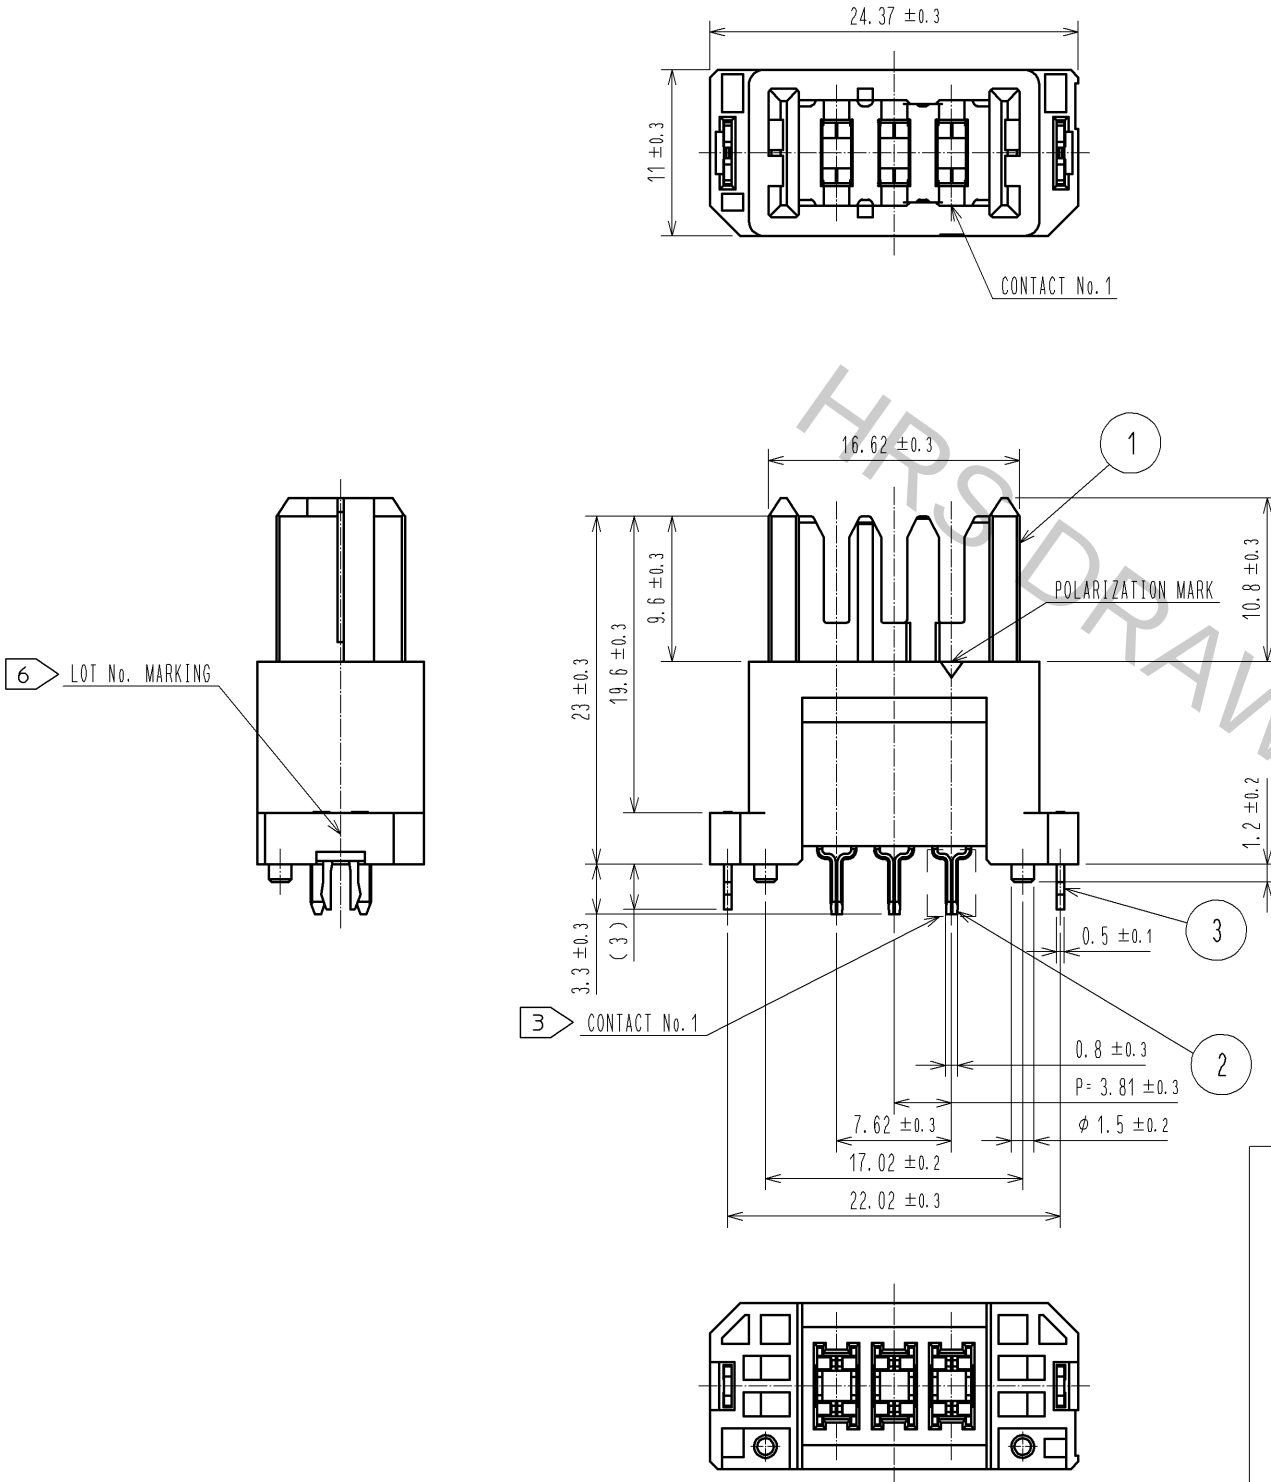
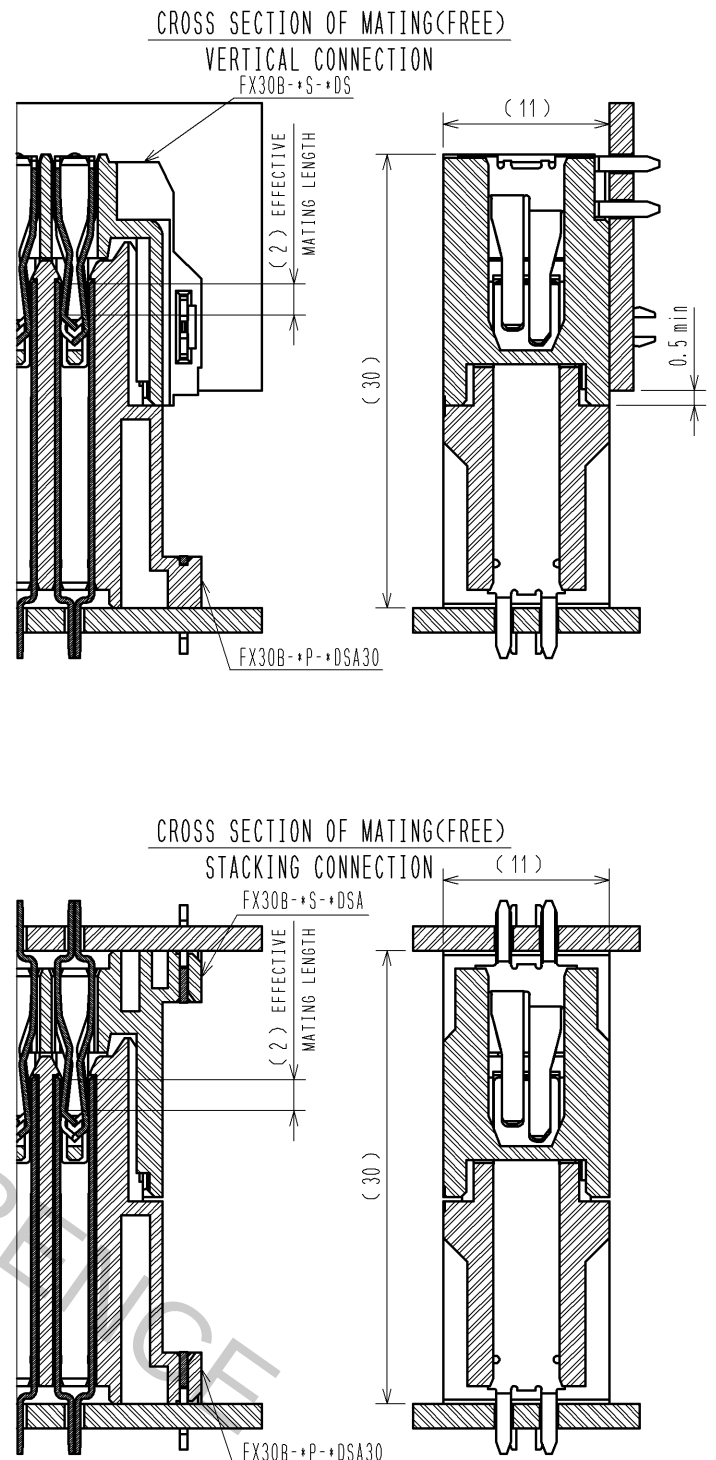
- THIS PRODUCT IS PACKAGED IN TRAY. (42pcs/TRAY)
- BLEMISH AND HIT MARK CAN BE OCCURED THROUGH OUT THE MANUFACTURING PROCESS WHICH DOESN'T AFFECT QUALITY LEVEL.  
ALSO, BLACK SPOT COULD BE OBSERVED ON THE SURFACE OF HOUSING.
- FOR THE CONTACT NO., ADJACENT TWO PAIRS OF LEADS PLACED BACK-TO-BACK (4 LEADS IN TOTAL) COMPOSE ONE LINE.
- MISALIGNMENT ABSORBING RANGE:  $\pm 0.3\text{mm max.}$
- THE DIMENSION IN PARENTHESES ARE FOR REFERENCES.
- LOT NO. IS INDICATED AT EITHER ONE OF THE POSITION AS SHOWN.
