# SAFETY NOTICE

## powerCON® TRUE1

Nr.: BDA 533 | Date: 20.12.2017 | Data subject to change without prior notice. ©2017 NEUTRIK®. ALL RIGHTS RESERVED. NEUTRIK® is a registered trademark.

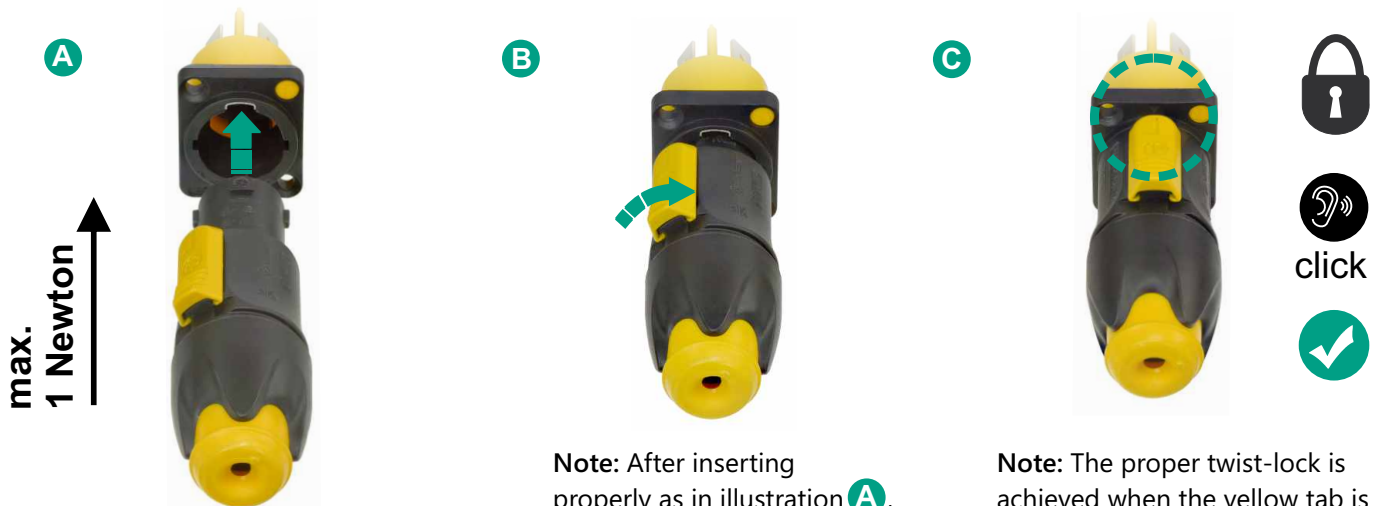
**Note:** When connecting, match the notch on the cable connector to the corresponding guide slot on the chassis.

**Note:** After inserting properly as in illustration **A**, twist the cable connector clockwise to lock.

**Note:** The proper twist-lock is achieved when the yellow tab is in the position shown in **C** and an audible «click» is heard.

To determine that the cable connector is inserted correctly, follow the use instructions and listen for the "click" when performing the twist-lock. Immediately unplug any connector that does not twist-lock correctly in place.

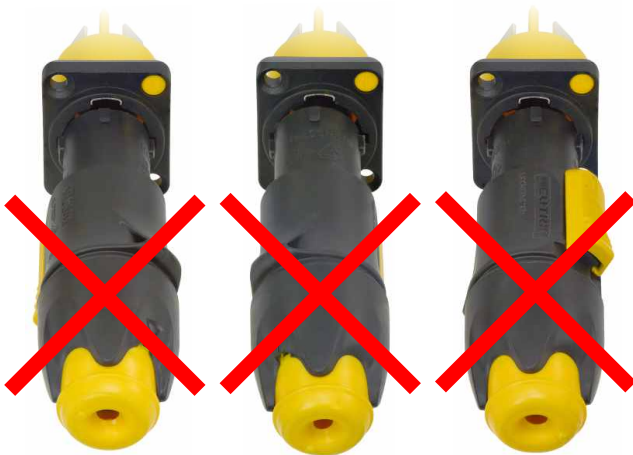
**SAFETY WARNING**

incorrect insertion may cause electrical contact misalignment resulting in equipment malfunction and/or personal injury.

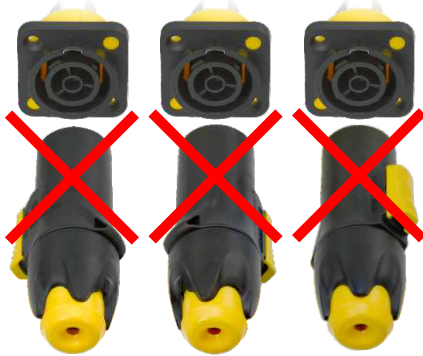
Note: When connecting, match the notch on the cable connector to the corresponding guide slot on the chassis.

max. 1 Newton

Note: After inserting properly as in illustration A, twist the cable connector clockwise to lock.

Note: The proper twist-lock is achieved when the yellow tab is in the position shown in C and an audible «click» is heard.

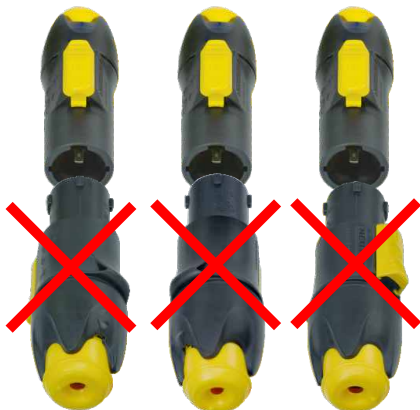
Note: When connecting, match the notch on the cable connector to the corresponding guide slot on the chassis.

max. 1 Newton

Note: After inserting properly as in illustration A, twist the cable connector clockwise to lock.

Note: The proper twist-lock is achieved when the yellow tab is in the position shown in C and an audible «click» is heard.
